28 February 2019

# SECOND EXPLOSION PIKE RIVER MINE / CONVEYOR BELT

This report summarises the investigation into the second explosion at the Pike River Mine on 24 November 2010 at 1437 hours and addresses reports in the media that the cause of the second explosion was the starting of the conveyor belt.

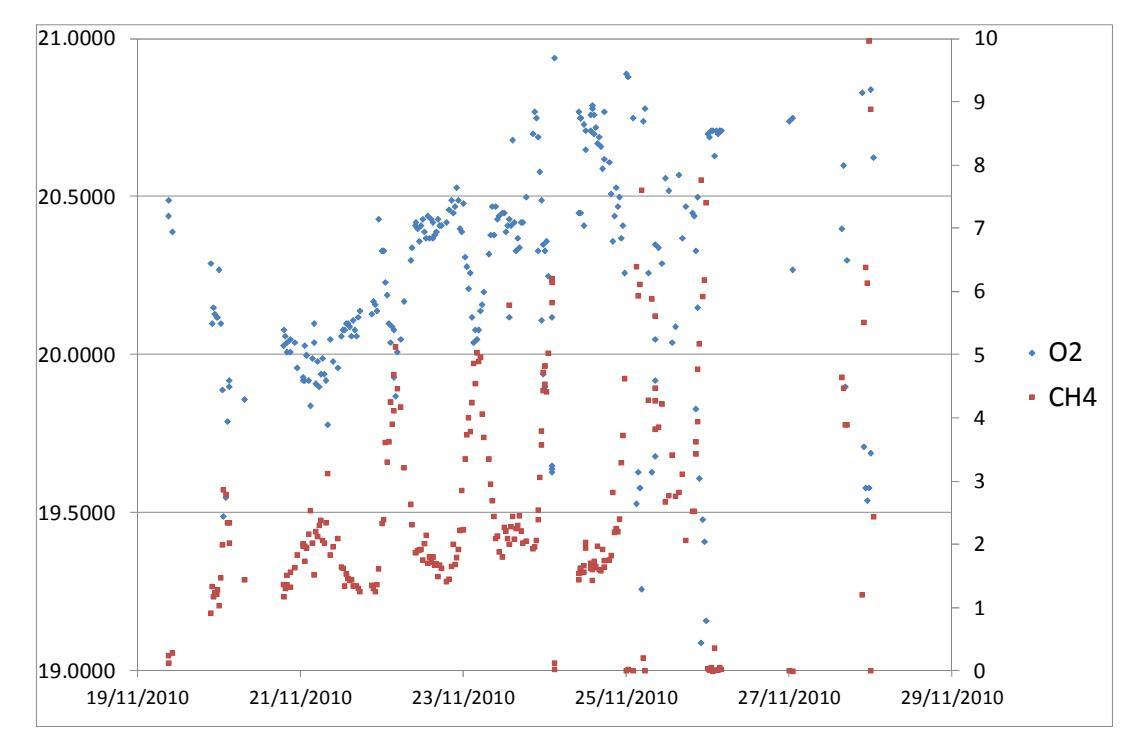
The only meaningful gas monitoring data available for analysis during the period after the first explosion is from the fanshaft. Manual samples were taken and analysed by GC. Sampling was subject to access to the top of the fanshaft and to replacing the damaged sample line after each explosion. Thus the sample regime is not continuous. The principle sources of gas at the sampling location were air that could enter the mine via the slimline shaft and the main stone drift, methane (and a small amount of carbon dioxide) exuding from the coal within the mine, post explosion gas and the products of any ongoing combustion.

Gas monitoring data from the fanshaft showing the diurnal variation in methane concentration (on the right hand y axis) over time.

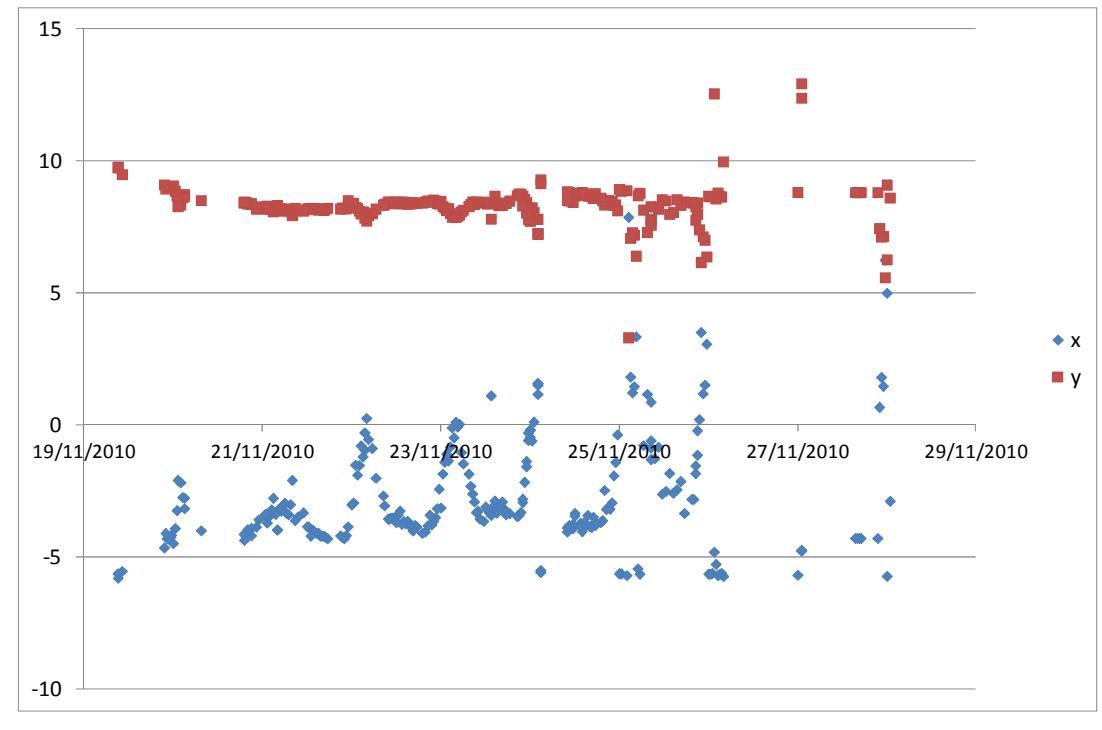
The two elements plotted are the x and y co-ordinates of the Ellicott explosibility diagram, an atmosphere is explosive when both x and y are positive. By considering the flows of gas in the mine, it is reasonable to assume that the point of ignition was generally in an area of fresh air that started to fill with methane under the influence of the barometer. This would limit the area where the ignition source could be to those roadways immediately connected to the roadway leading from the stone drift to the fanshaft.

Given the data from PRHD43 days previously it is reasonable to assume that the working area of the mine is essentially full of methane. Over time the fringe of methane would slowly work toward the fanshaft roadway. Air also entered the mine via the slimline.

Figure 2. Ellicott explosibility parameters as a function of time at the fanshaft.
