CTV Investigation

Engineering Opinion Report

CTV Building Collapse - Engineering Opinion Report

Prepared for New Zealand Police

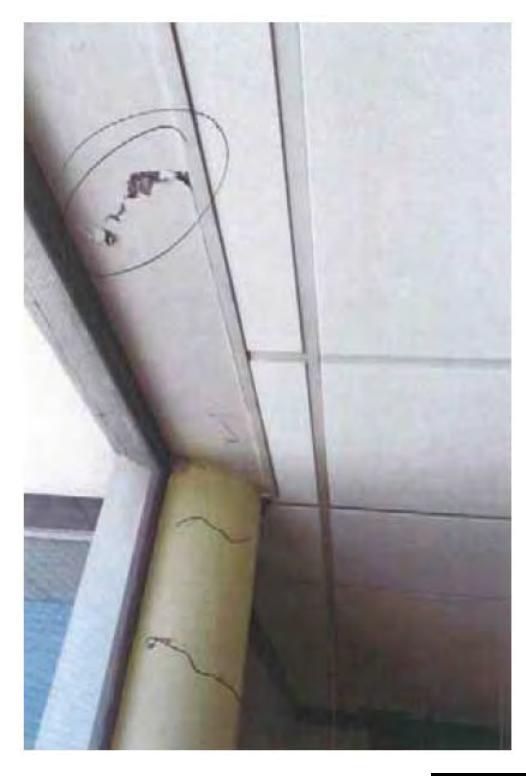
- Further cracking of glass around the perimeter
- Potentially further cracking to plasterboard of internal partition walls and linings
- Gaps between the steel window frames and the surrounding concrete structure that had potentially widened
- Potentially further cracking in the walls and stairwells of the North Wall Complex at several floor levels
- Potentially further cracking of isolated internal columns
- Potentially further damage to the lintel of wall D-E at level 7 near its connection to column C18 (Figure 6.1).

Figure 6.1: Cracking to column C18 and lintel of wall D-E at level 7 (Source:

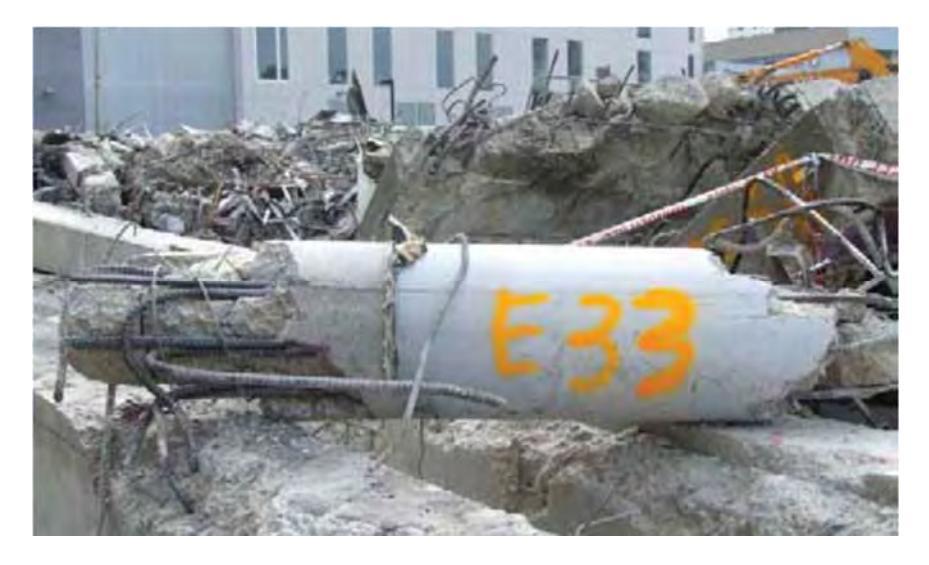
Due to the pancaking nature of the collapse, the majority of the internal columns were not sighted after collapse, and it is likely they were reduced to rubble during the collapse sequence. However, a number of perimeter columns and interior columns above level 6 remained intact. Therefore, those segments of columns that were photographed were likely to be from the perimeter of the building. One investigator gave evidence to CERC that the observed column segments generally had damage only at their ends with the central section largely intact (Figure 6.4).

Figure 6.4: Perimeter column with intact central portion (Source:

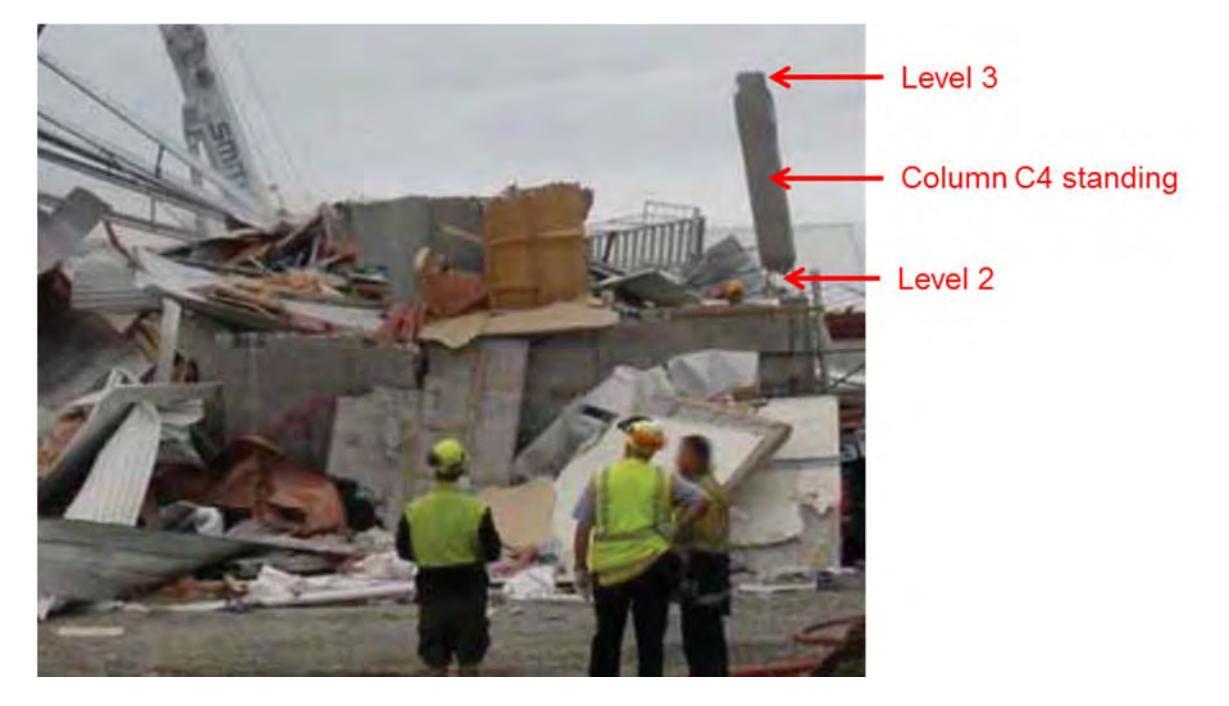
Column C4 in the south-west corner of the building remained standing up to what appears to be level 3, with concrete missing from the joint zone at level 2 (Figure 6.5).

Figure 6.5: Column C4 standing post-collapse up to level 3 (Source: Hyland/Smith 2012)

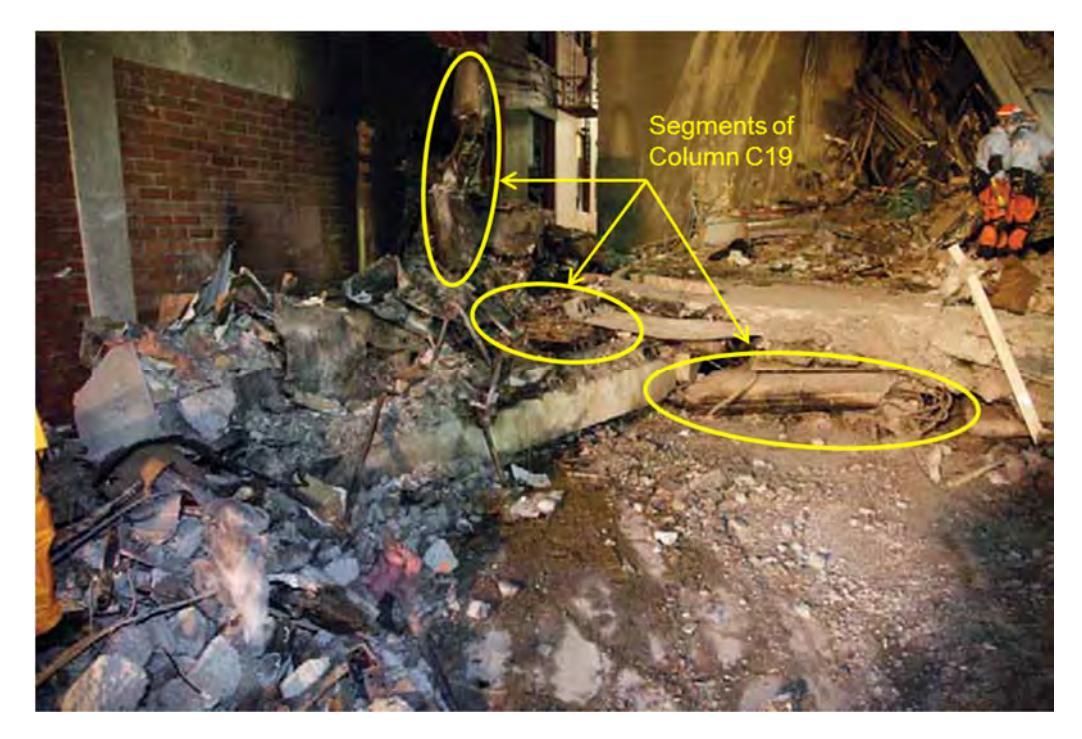
Column C19 near the north-west corner was observed having fallen towards the north with a segment resting up against the neighbouring building (Figure 6.6).

Figure 6.6: Column C19 fallen towards the north (Source:

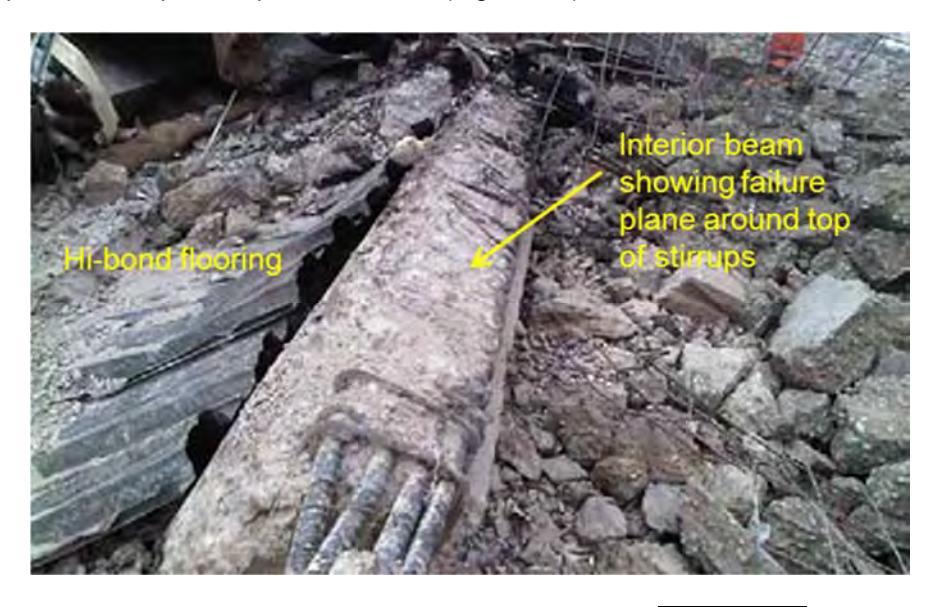
The beams were largely intact with the damage typically concentrated at the ends, and the central section intact. Generally, the floor slabs had detached from the beams with the failure plane aligning with the tops of the beam stirrups and the top of the precast section (Figure 6.7).

Figure 6.7: Interior beam showing failure plane around top of stirrups (Source:

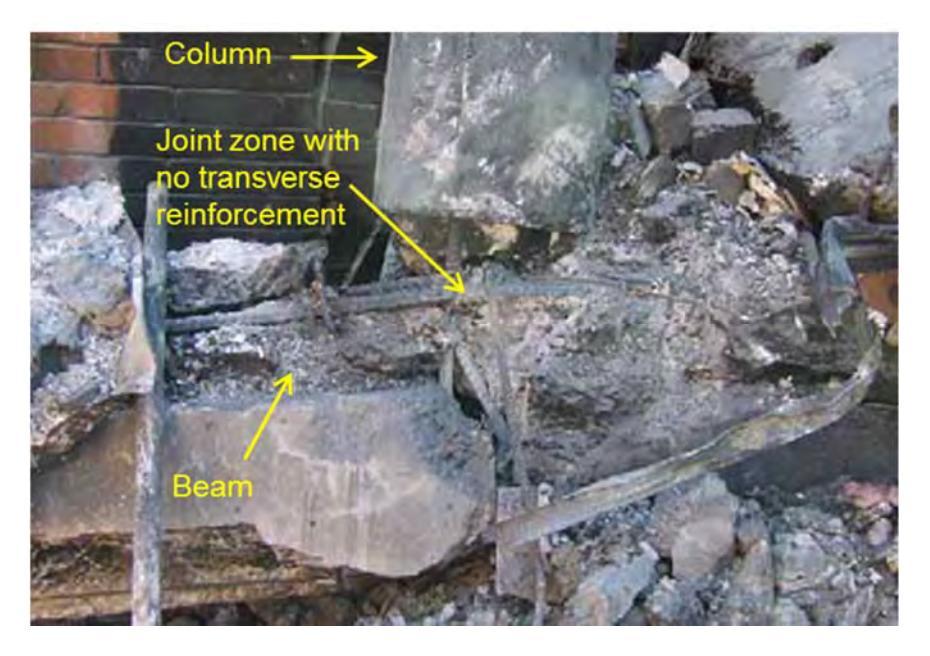
The investigators reported that they did not see any beam-column joints intact except at level 6. They also did not see any evidence of transverse reinforcement in the joint zones (Figure 6.8). In observing the beam-columns joints, the investigators also noticed the wings at the ends of the precast beams had mostly broken off and the beam ends were smooth where they met the in-situ face of the column.

Figure 6.8: Beam-column joint region with no transverse reinforcement (Source:

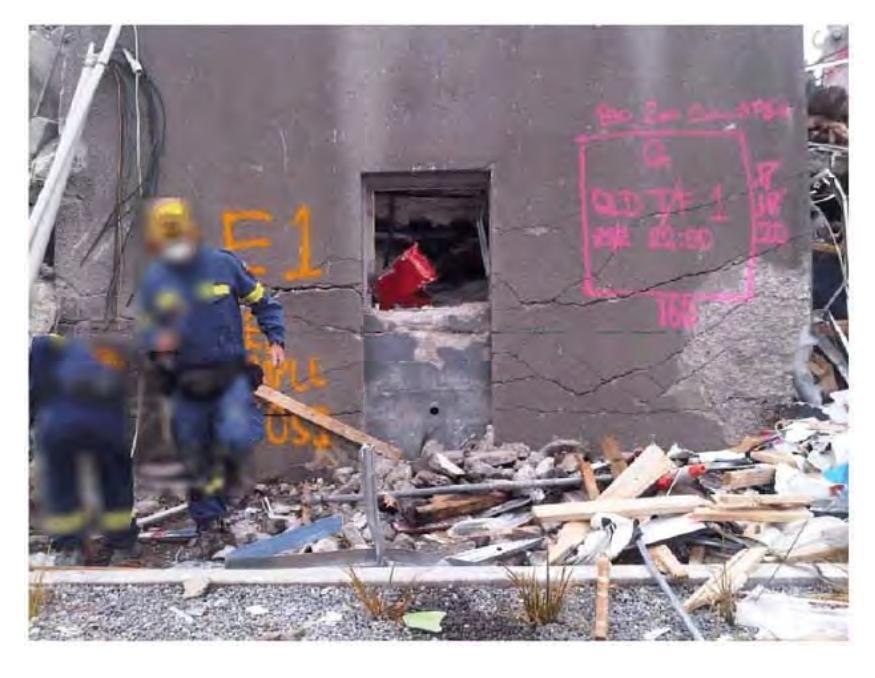
The CERC report presented evidence from a USAR engineer who concluded that the cracks near the base of the wall were indicative of out-of-plane bending and that, due to the lack of significant damage to the coupling beams, surmised that the South Shear Wall saw little in-plane loads. This is contrary to the Hyland/Smith conclusions that the cracks near the base of the wall were indicative of the wall behaving as a flexural cantilever in-plane. The CERC report made an assessment of the coupling beam strengths relative to the base of the wall and concluded that the South Shear Wall would have acted in-plane predominantly as a single unit, which is consistent with the observed cracking.

Figure 6.9: South Shear Wall cracking near the base (Source

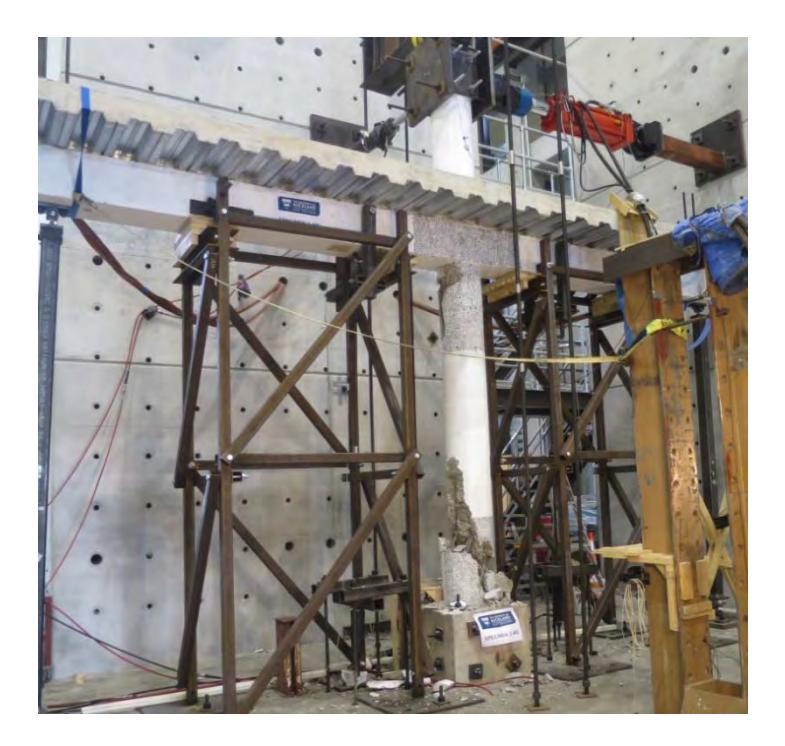
Figure K11: Overview of As-designed specimen following failure at approximately 95mm in-plane Level 2 displacement

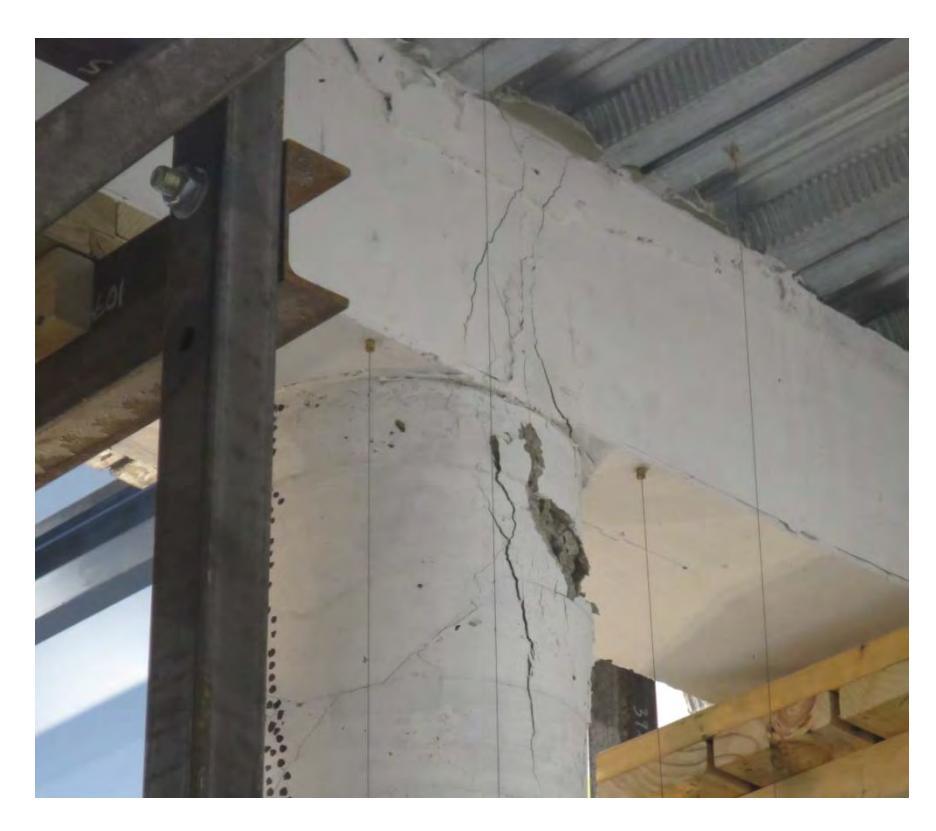
Figure K13: Joint exterior damage following failure of As-designed specimen at approximately 95mm in-plane Level 2 displacement

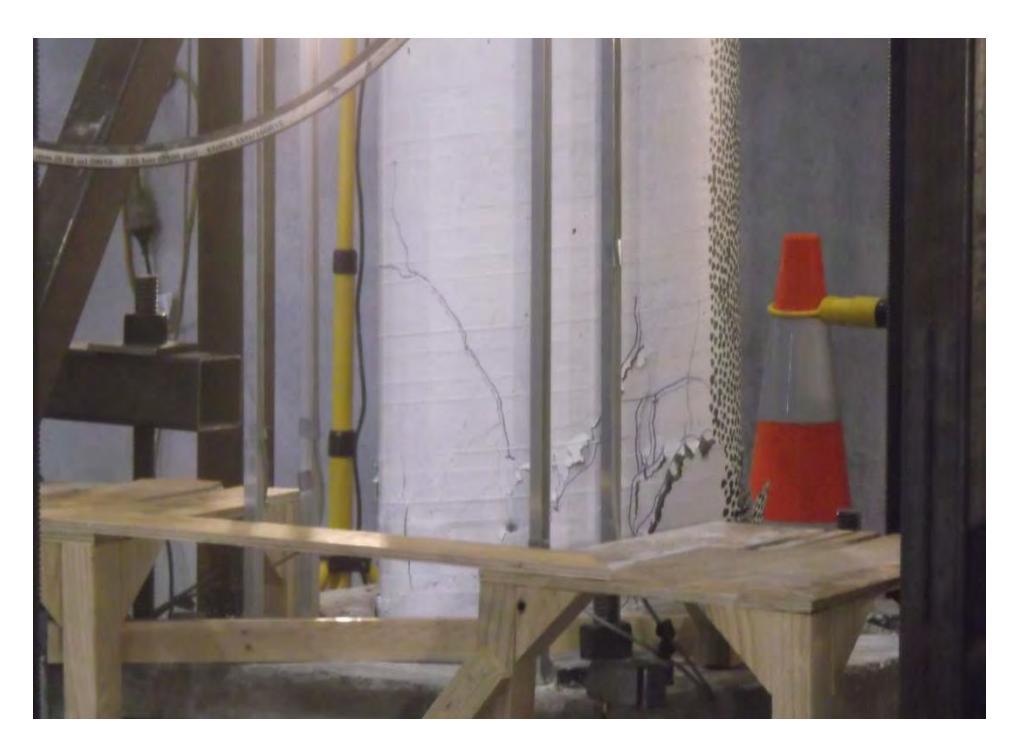
Figure K15: 'Compliant design/construction errors' specimen bottom of lower column damage at end of step 3 (max applied in-plane drift of 69mm)

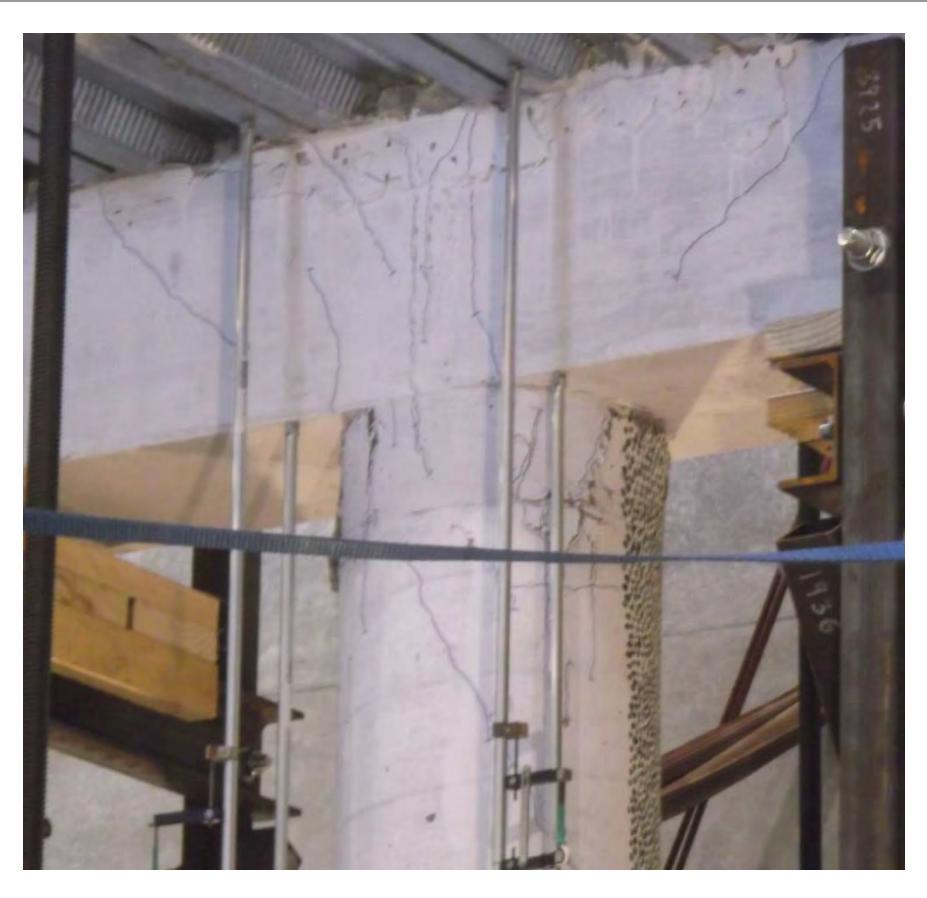
Figure K16: 'Compliant design/construction errors' specimen top of lower column/joint damage at end of step 3 (max applied in-plane drift of 69mm)

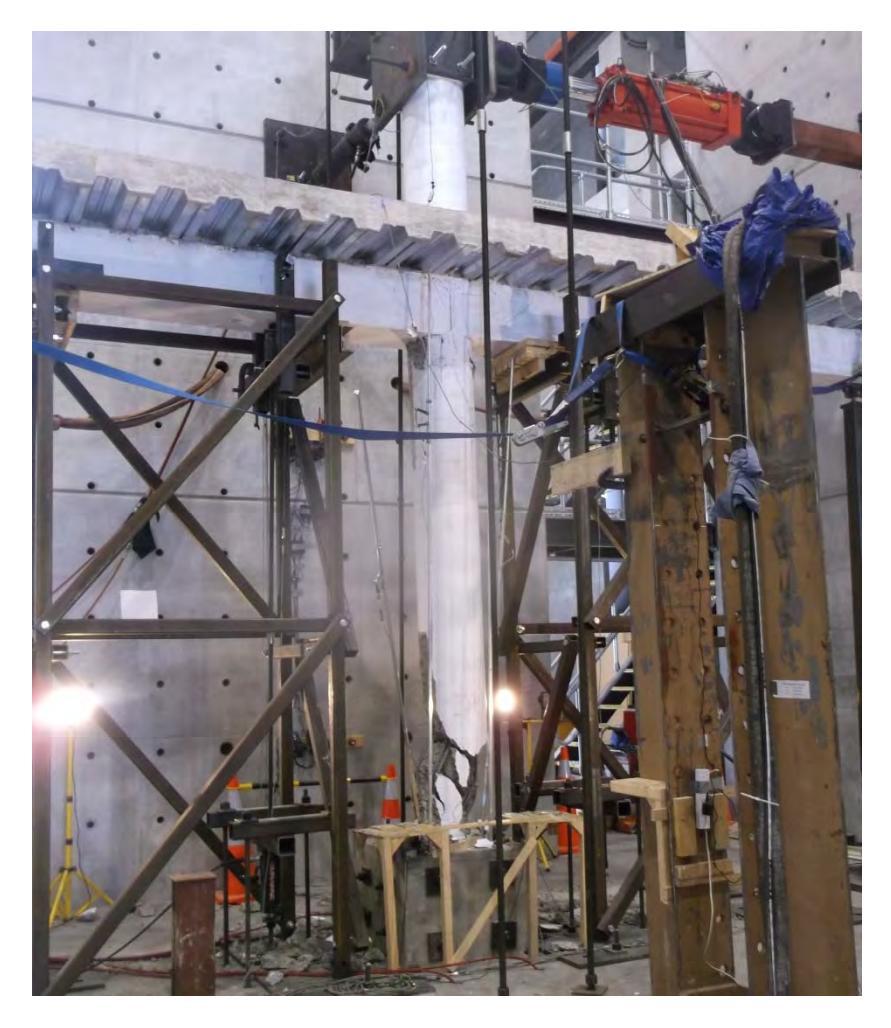
Figure K17: Overview of 'Compliant design/construction errors' specimen following failure at approximately 75mm inplane Level 2 displacement

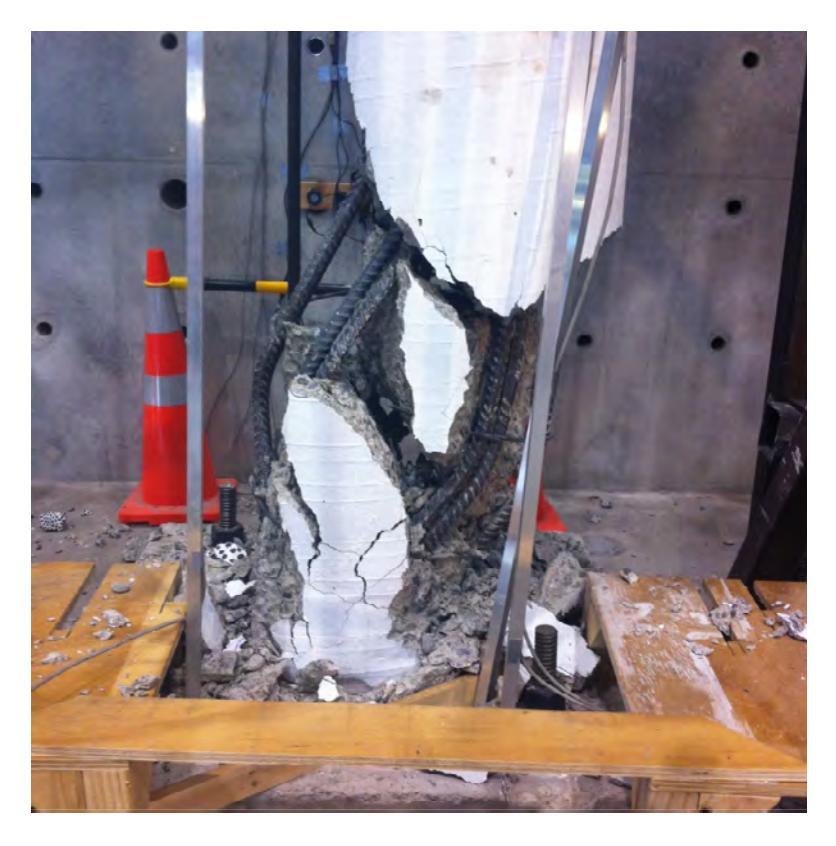
Figure K18: 'Compliant design/construction errors' specimen bottom of lower column damage following failure at approximately 75mm in-plane Level 2 displacement

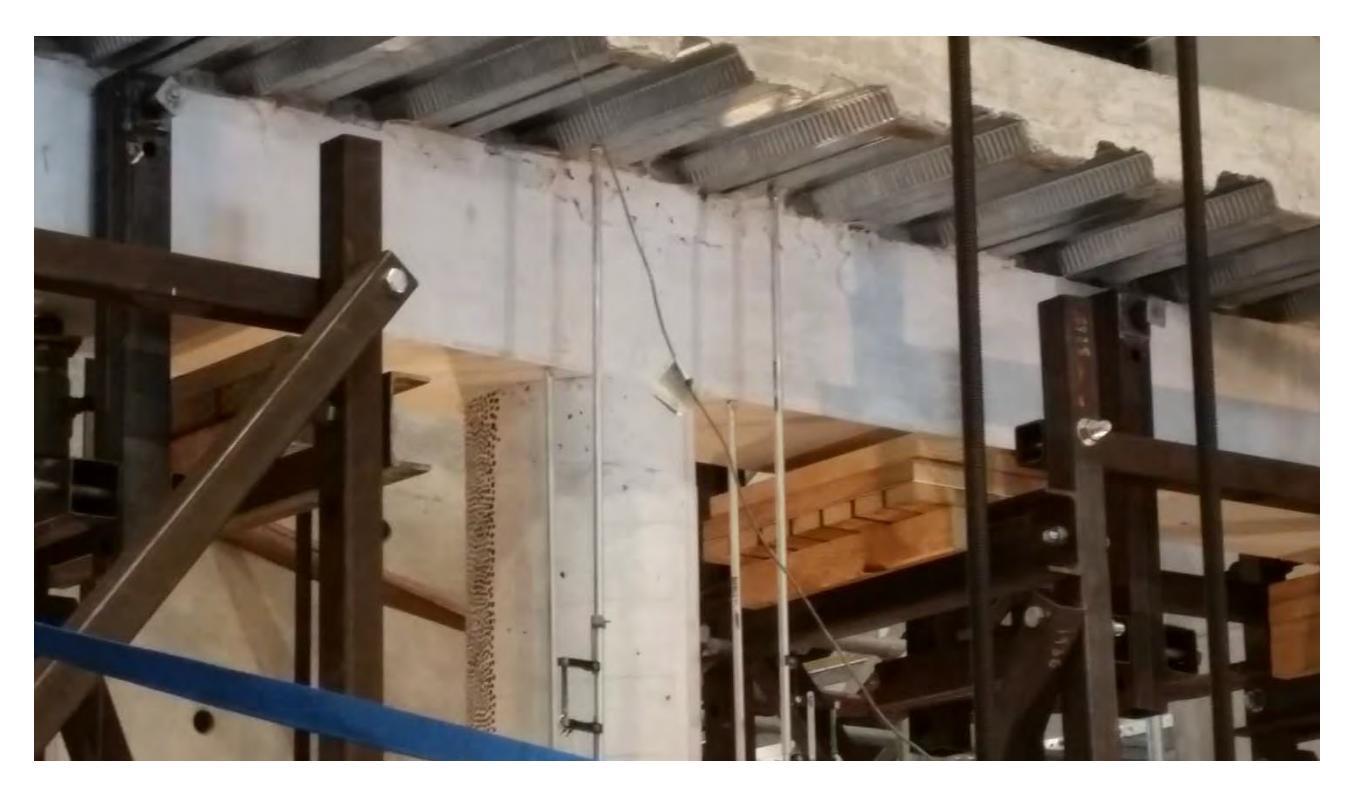
Figure K20: 'Compliant design/construction errors' specimen joint region at the end of cycle 4 after a maximum interstorey displacement of 30mm

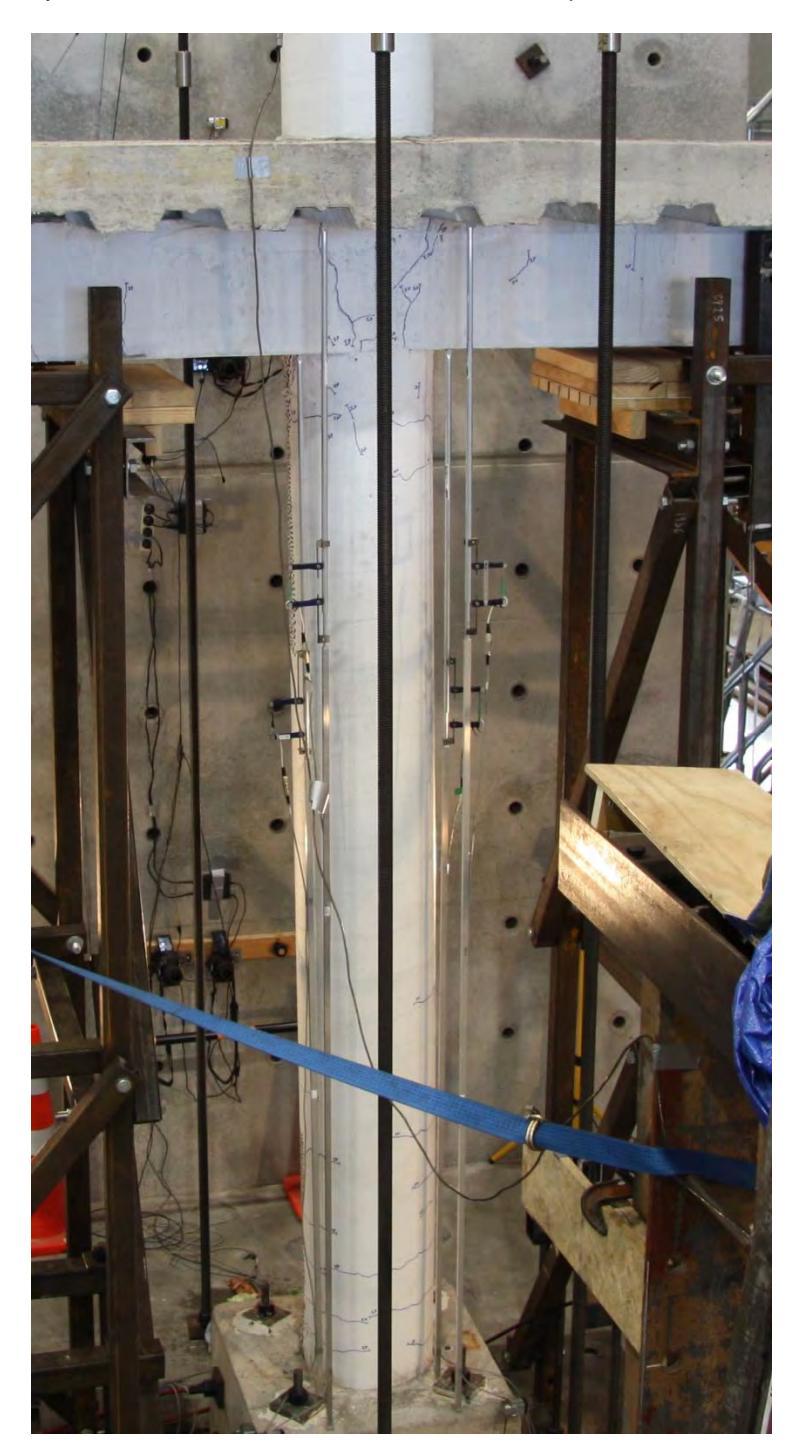
Figure K22: Code-compliant specimen at the end of step 3 of the loading sequence (max applied in-plane drift of 69mm)

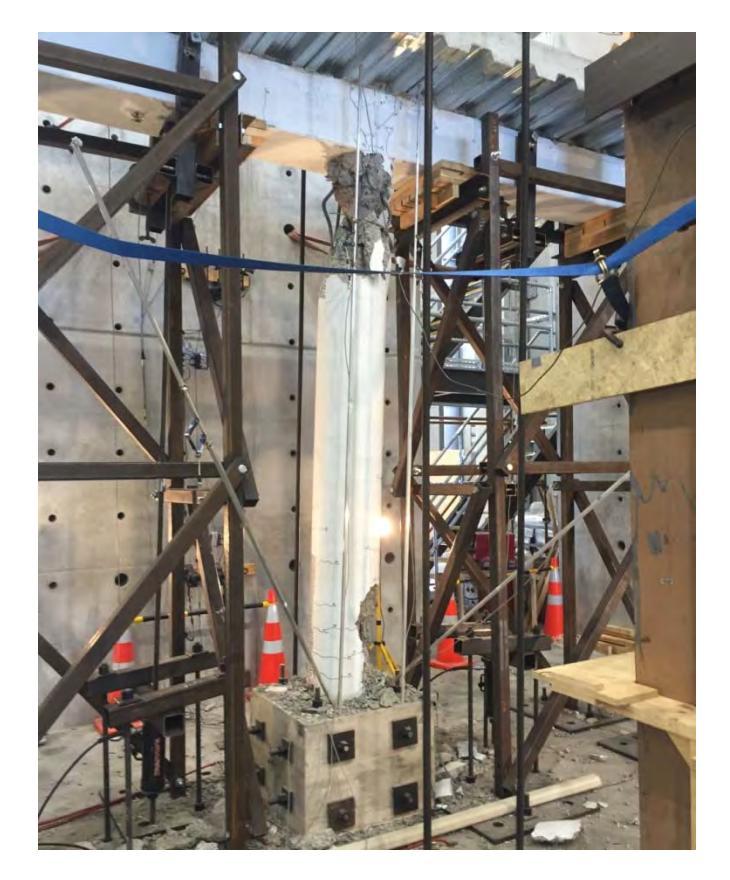
Figure K23: Overview of Code-compliant specimen following push to failure at an in-plane displacement of 150mm

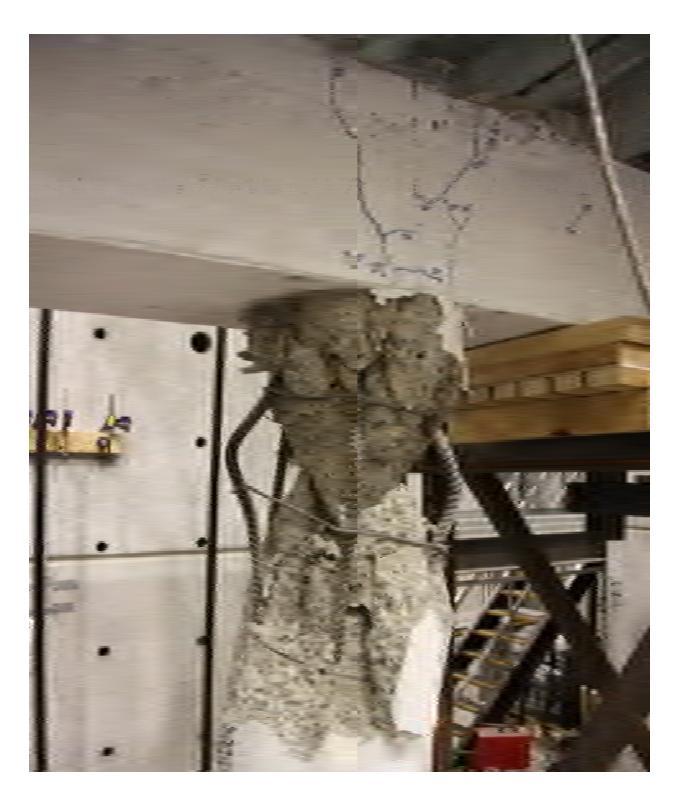
Figure K24: Top of lower column of Code-compliant specimen following push to failure at an in-plane displacement of 150mm
