Working Together To Create Safe Crossing Points For Our Children

Prepared by Ian Anderson
School Community Officer - Whangarei

Challenge

- Poorly maintained and incorrectly painted school patrol crossings (kea crossing and pedestrian crossing) in the Whangarei area.
- 16 out of 18 school traffic safety team crossings were found to have faults.

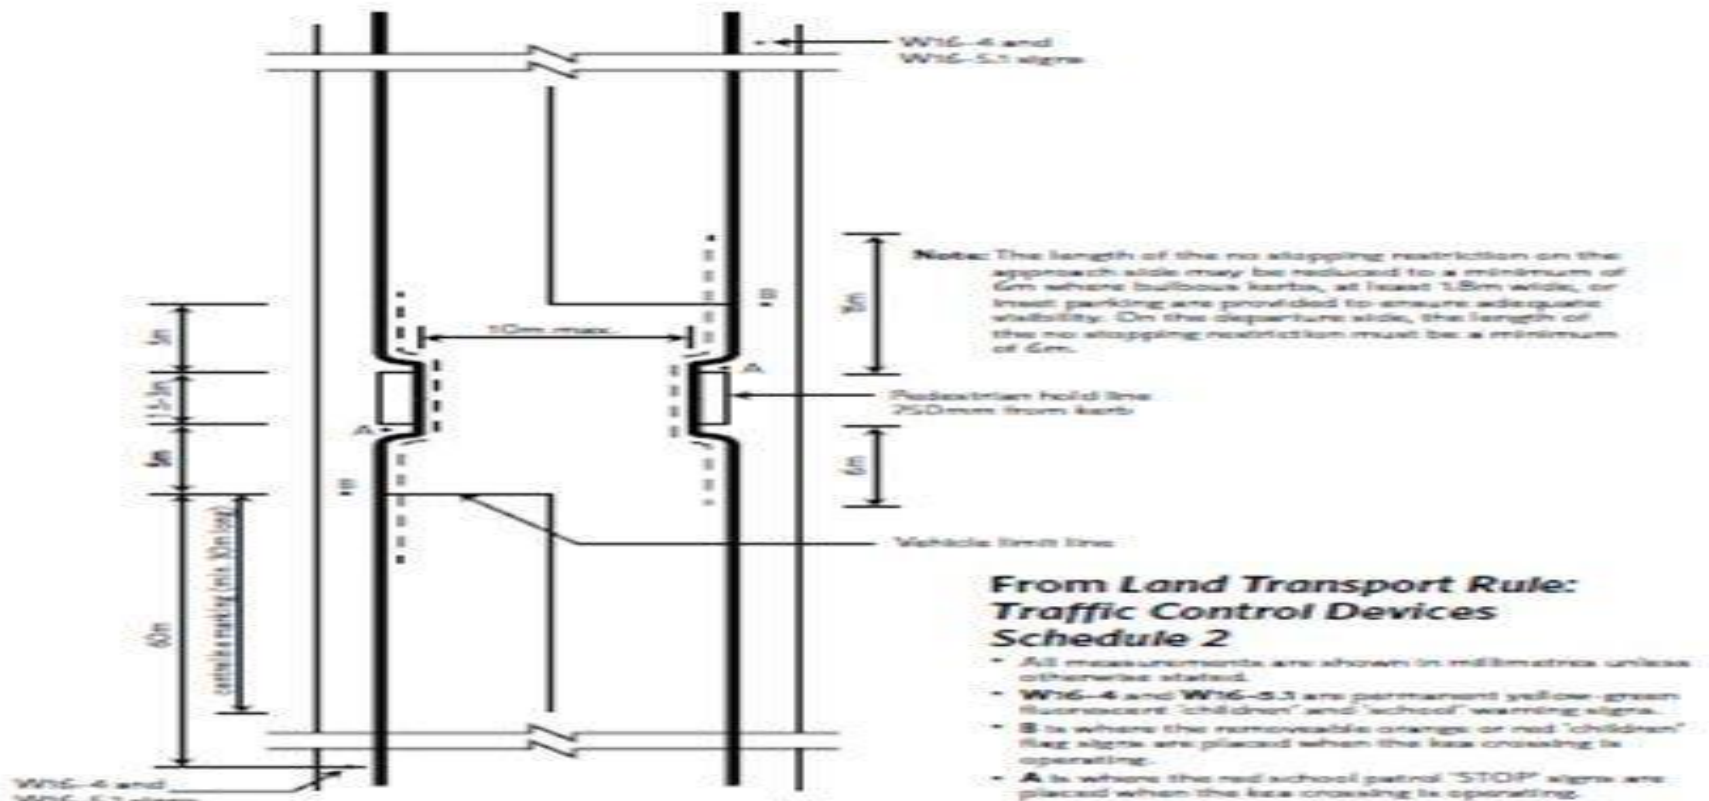
8.2 Kea crossing specifications

This diagram is also available online at education.nzta.govt.nz.

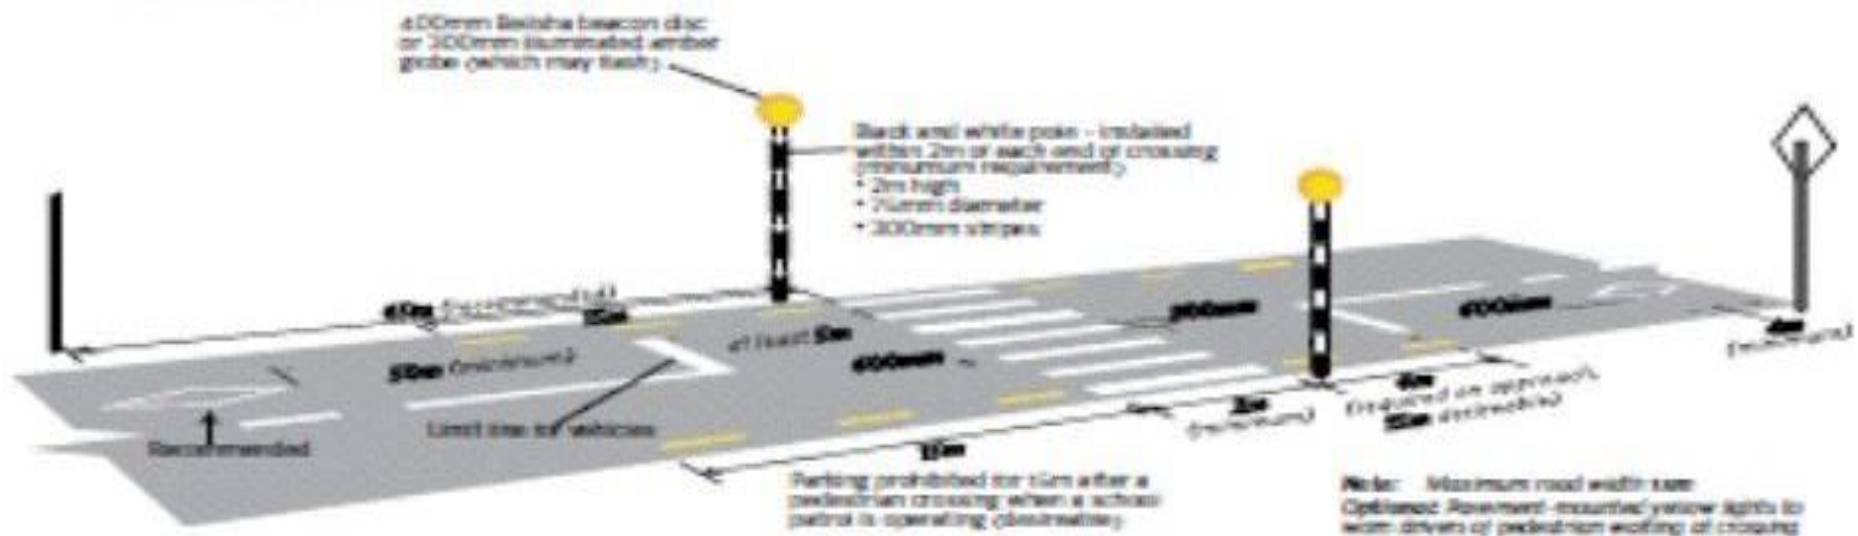
8.1 Pedestrian crossing specifications

Typical marking of pedestrian crossing in a 50km/h area

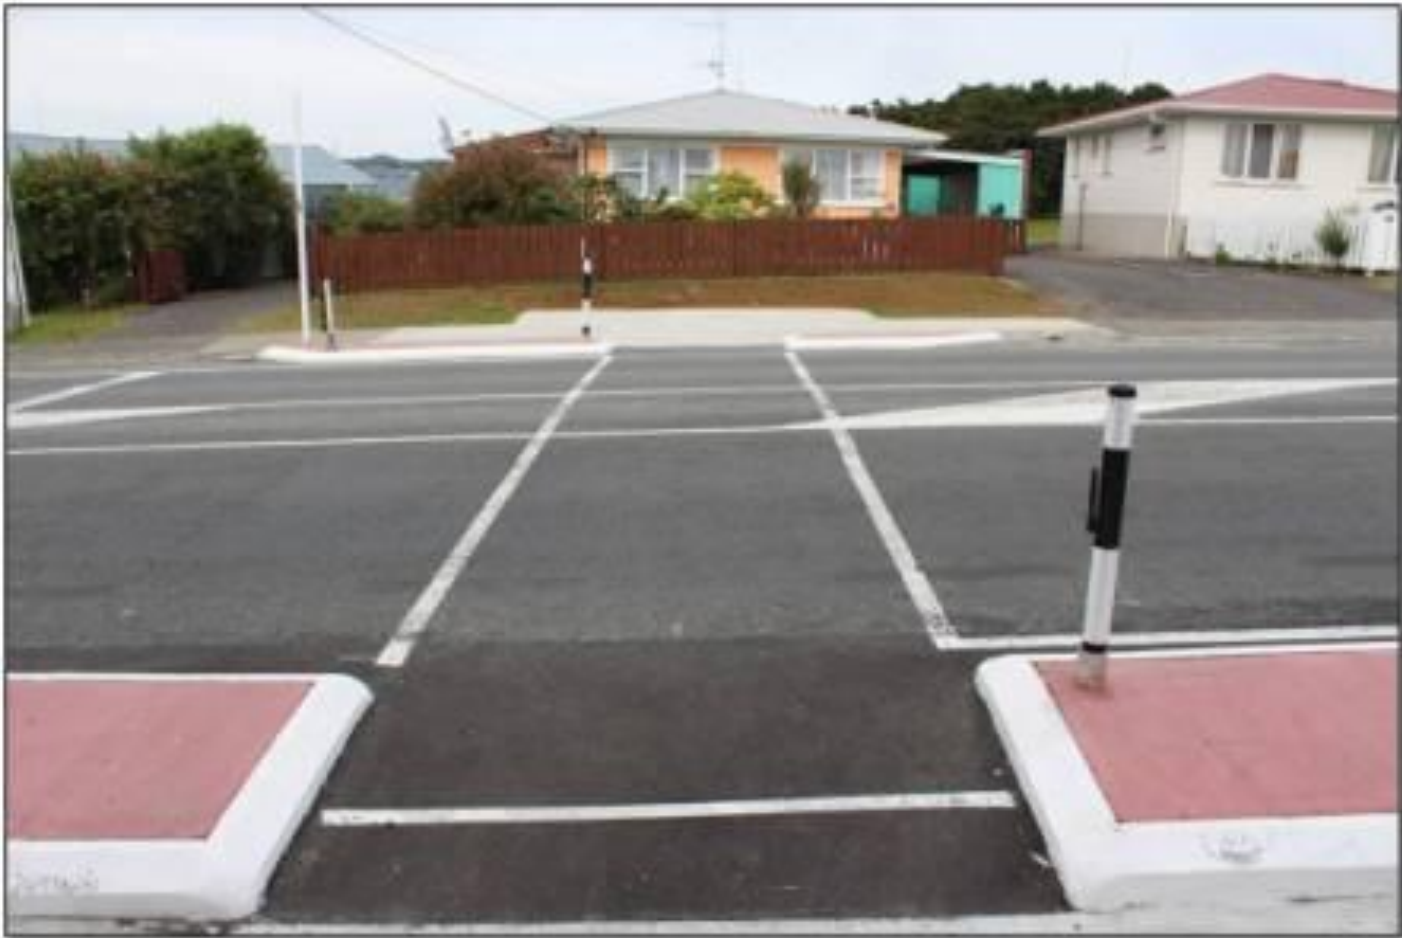
Totoro Grove School

- Incorrectly painted Kea road markings.
- Children confuse Kea Crossing with Zebra Crossing
- Visibility from South on Paramount Parade
- Legislative Consideration: “8.4(5) A road controlling authority must indicate the presence and position of a school crossing point by marking or installing in accordance with the relevant requirements of schedule 2.

- Incorrect painted road markings removed.
- Protective centre island put in place to assist students crossing the road.
- All children from the school taken through the new Kea crossing system.

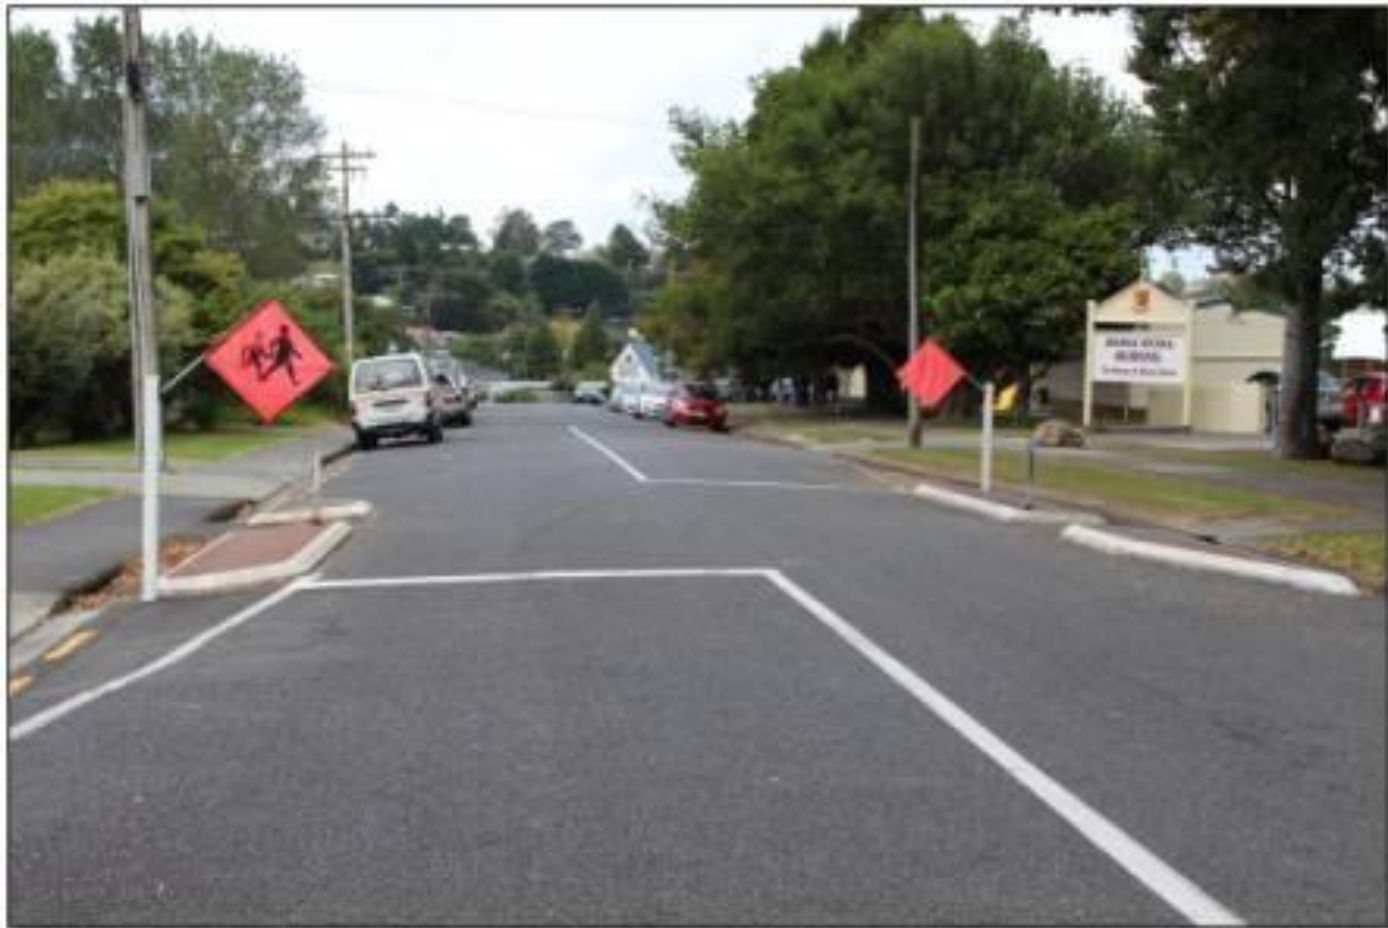
Horahora School

- Patrollers' view obstructed, particularly from a child's perspective
- Legislation "The W16-4.1 children flag on each approach should be mounted so it ... does not obscure the school patrol's view of approaching traffic."

- Changed the removable fluorescent orange (red 'children' flag) post to an appropriate height to prevent obstructing patrollers view.
- Extended the no stopping lines to assist the school patrollers.

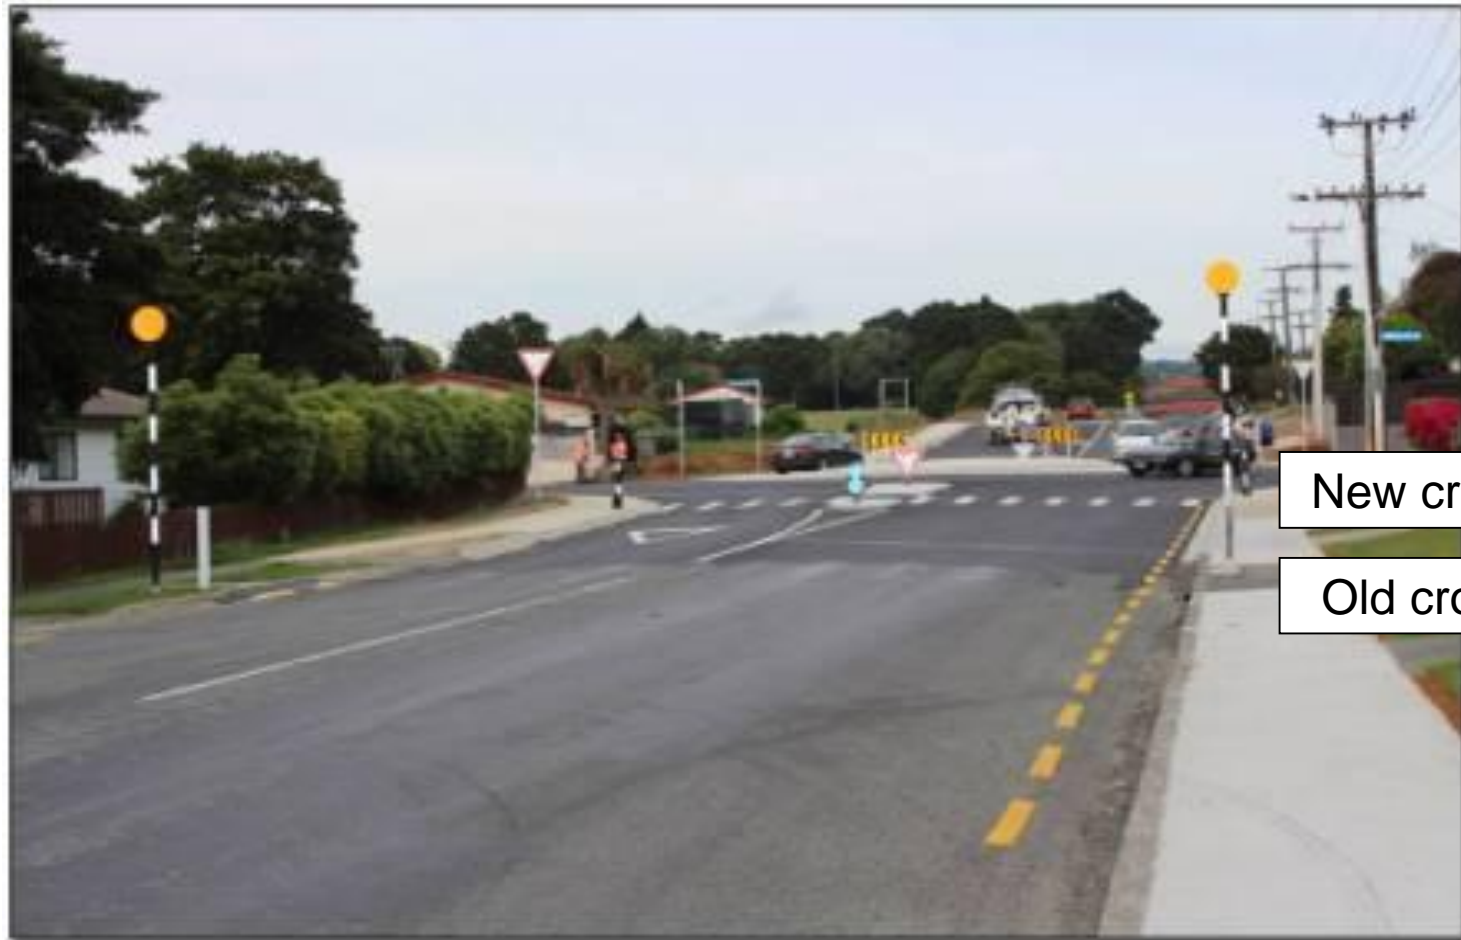
Totara Grove School Pedestrian crossing

New crossing site

Old crossing site

- The new pedestrian crossing was placed too close to busy roundabout.
- School Traffic Safety Team members at risk of being hit by vehicles or school patrol sign as vehicles enter intersection from side road.

- The pedestrian crossing was moved back to its original site further up the road (see photo).
- Teachers were stationed to oversee the crossing before and after school to assist children crossing.

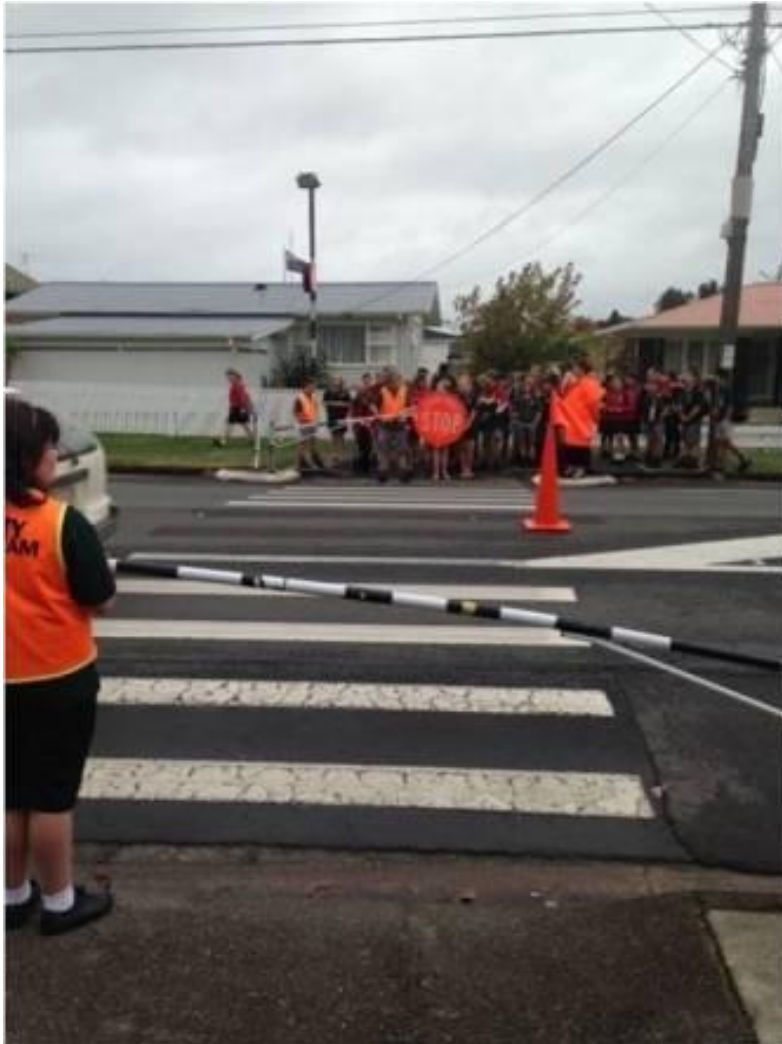
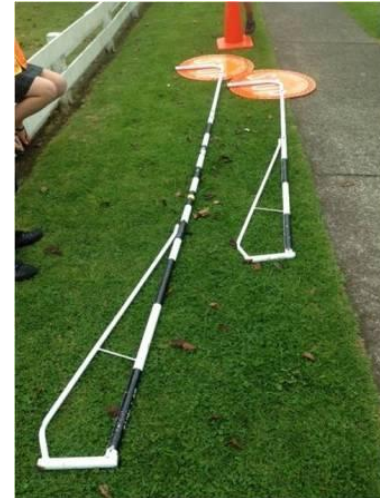
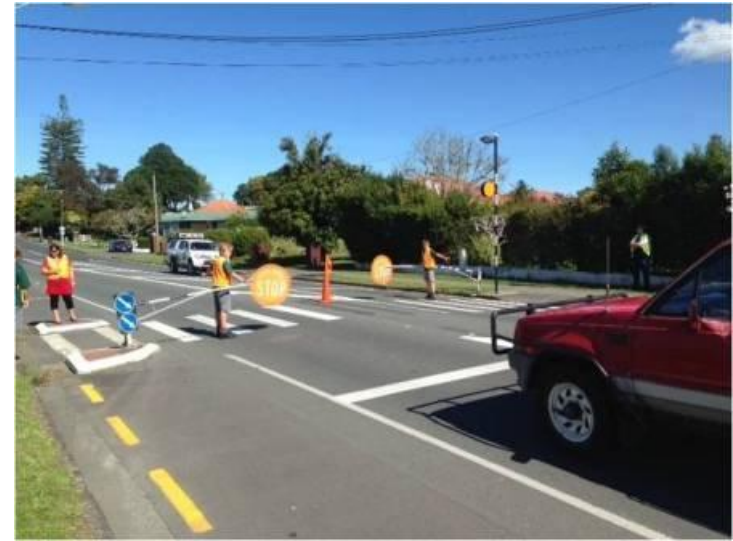
Kamo Intermediate

Missing Centre lines

- Different sized signs.
- Missing painted lines.
- Very busy road.
- Large number of students.
- Only one safety island

- Replace stop signs with appropriate evenly sized signs.
- Repaint the pedestrian crossing.
- Fit another protective traffic island to assist patrollers.
- Fit a centre traffic island to assist crossings.

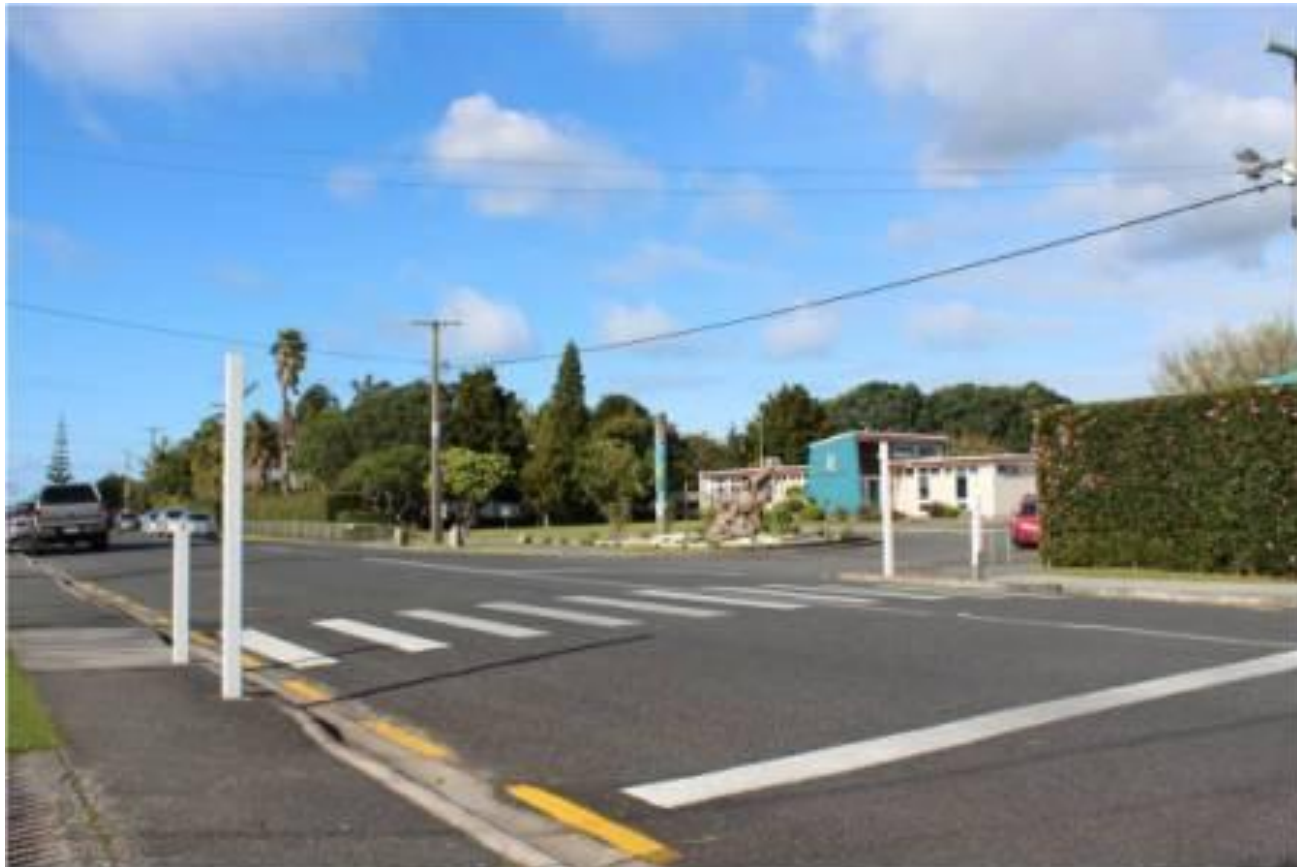
One Tree Point school

- No Belisha beacon disc or 300mm Illuminated amber globe.
- No black and white pole.
- Old Kea crossing posts.
- Busy road.

- Removed old Kea crossing flag posts.
- Installed black and white poles with Belisha beacon disc or 300mm illuminated amber globe (which may flash).
- Installed temporary 40km speed zone lights.
