CTV Investigation

Engineering Opinion Report

CTV Building Collapse - Engineering Opinion Report

Prepared for New Zealand Police

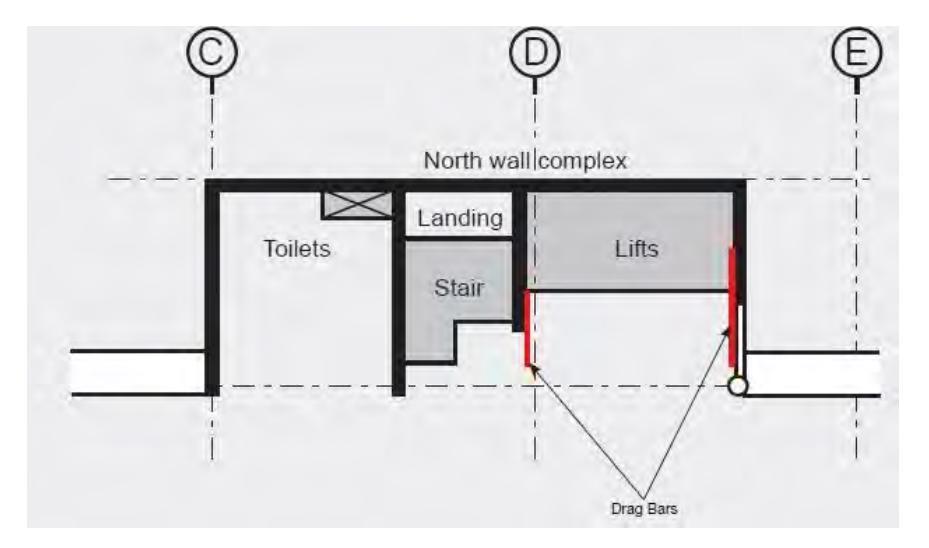
Steel angle drag bars were fitted to the floor slabs and walls at grids D and D-E of levels 4 to 6 in October 1991 (Figure 5.10). The drag bars consisted of steel angle sections bolted to the underside of the slabs and to the shear walls.

Figure 5.10: Locations and extent of drag bars installed on levels 4, 5 and 6 at walls D and D-E (Source: CERC Report 2012)

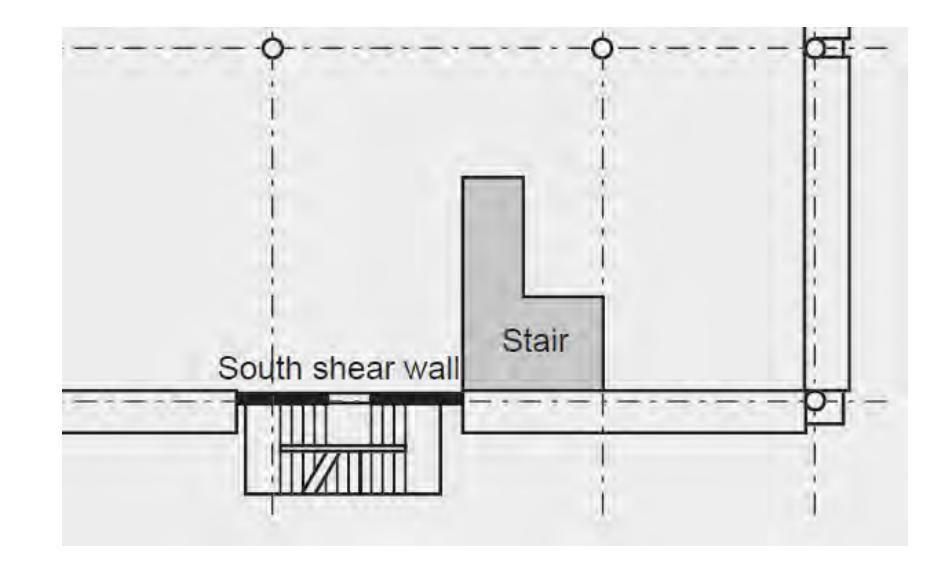
A stair penetration was cut in the floor of level 2 during a fit-out in 2000 (Figure 5.11).

Figure 5.11: Location of stairwell penetration cut in level 2 floor slab in 2000 (Source: CERC Report 2012)

The most significant alteration was the cutting of a penetration in the level 2 floor slab in the location indicated in Figure 5.11. The placing of the penetration in this location reduced the length of slab attached to the grid line 1 beam and therefore the ability to transfer loads to the South Shear Wall at level 2. However, as shown in Section 7.3.7, we have calculated the load to be transferred at level 2 to be significantly lower at level 2 than at the upper levels of the building. Even with the reduction in slab-to-beam length, the level 2 slab is calculated to be less stressed than at the upper levels. The penetration is expected to have minimal effect on the seismic load paths through the level 2 slab. Therefore, we have concluded that the introduction of the penetration in this location did not increase the collapse potential of the building.

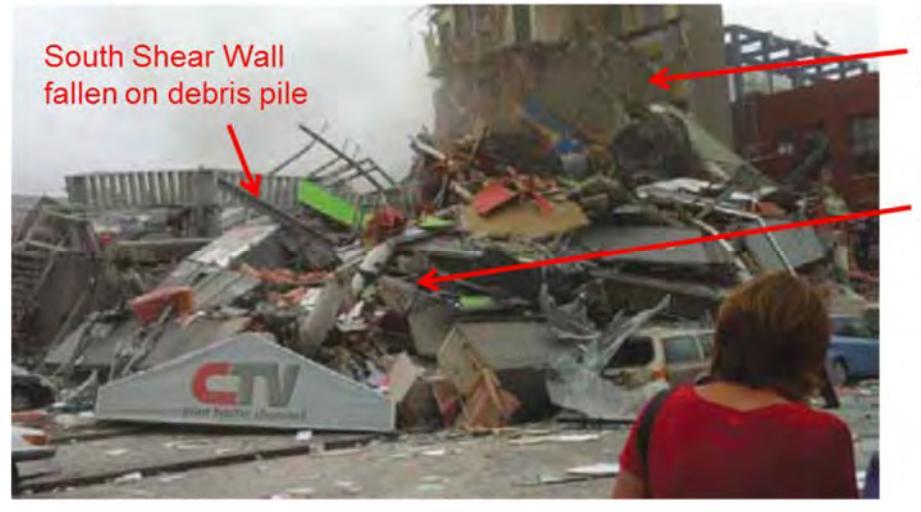
After collapse, the remnants of the building were resting mainly within its own footprint, with the North Wall Complex still standing, the floor slabs lying on top of each other, and the South Shear Wall having fallen inwards on top of the roughly 4m high debris pile (Figure 6.2). Remnants of floor slabs were leaning up against the North Wall Complex.

Figure 6.2: Photo taken immediately following collapse (Source:

North Wall Complex still standing

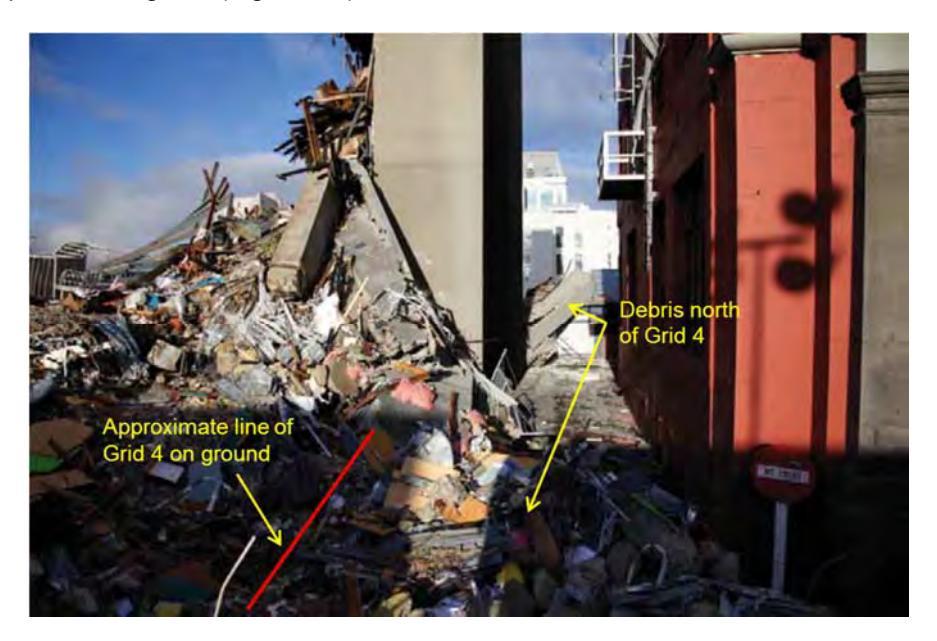
The only areas where debris appeared to fall outside the main footprint of the building were on the east and north sides, with debris having fallen on parked cars in Madras Street (Figure 6.2) and several metres north of their original position on grid 4 (Figure 6.3).

Figure 6.3: North-east corner of the building looking west showing debris lying north of grid 4 (Source:

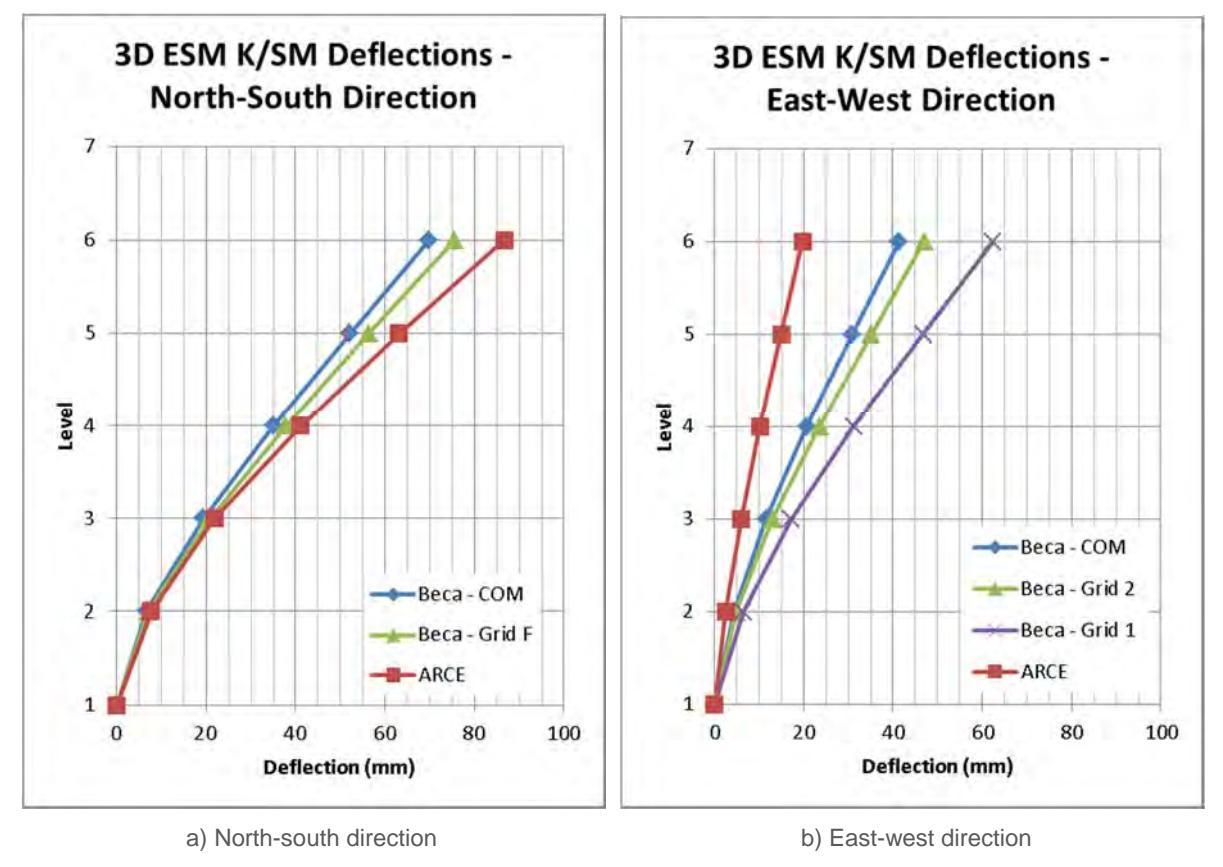
Figure 7.2: 3D Equivalent static method K/SM scaled deflections

Figure 7.2a shows that the deflections calculated by Mr Harding in the north-south direction are higher than our calculated values for both the centre of mass and grid F. Our results also show that the building is not very susceptible to torsional rotations for loading in the north-south direction because the centre of mass and grid F deflections are similar. Overall, the deflections calculated by Mr Harding in the north-south direction are higher than those we have calculated.

Figure 7.2b shows that the deflections calculated by Mr Harding in the east-west direction are much lower than our calculated values at the centre of mass (by a factor of 2). Our results also show that the building is susceptible to torsional rotations for loading in the east-west direction because the deflections at grid 1 are significantly larger than at the centre of mass. Mr Harding was reporting a much higher period in the east-west direction than our analysis shows, and yet had smaller deflections, which is the reverse of what would have been expected (i.e. higher period, greater implied flexibility, higher deflections expected). This suggests that the period reported by Mr Harding for the east-west direction is likely to be in error, and hence the period scaling factor of 0.712 was not justified. Overall, Mr Harding has significantly underestimated the deflections of the building in the east-west direction. Mr Harding also failed to report values at grids offset from the centre of mass which would have produced even larger deflections.

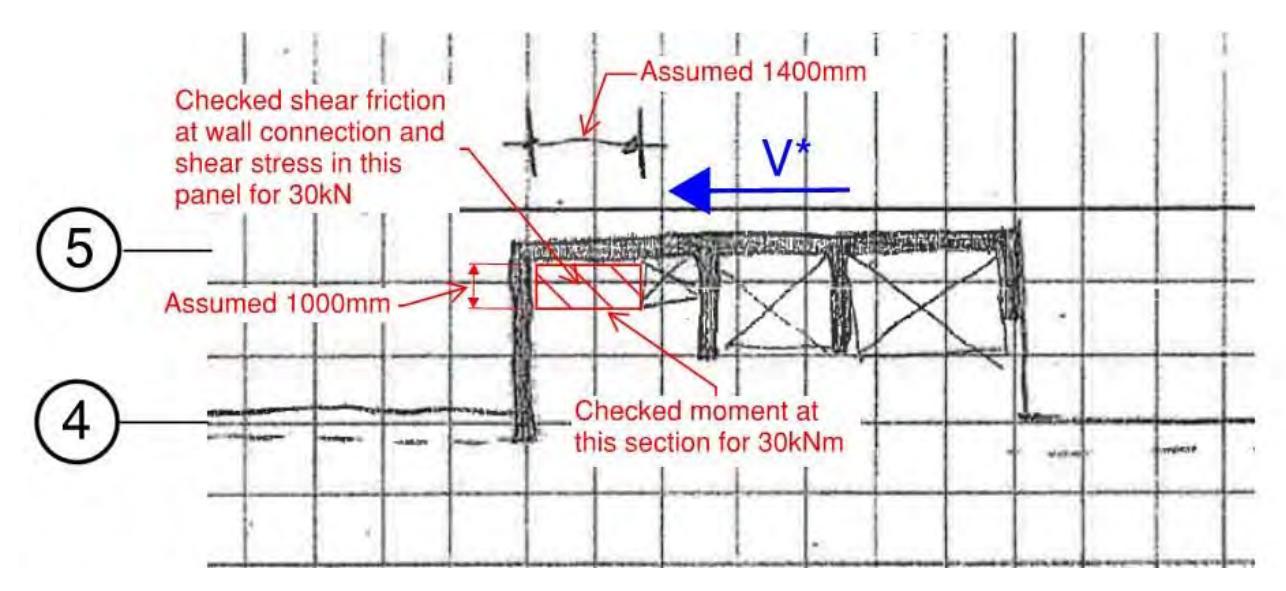
For the North Wall Complex connection, Mr Harding calculated the shear demand in a 1.4m length of slab using a force of 30,000N and concluded this to be "OK" (Figure 7.3). It is not clear why he used 30kN instead of 300kN, which suggests a possible numerical error. It is also not clear why he used a slab length of 1.4m,

He then calculated a bending moment demand in the 1.4m length of slab using a force of 30kN and a lever arm of 1m. Again, it is not clear why he used 30kN instead of 300kN. It also not clear why he used a lever arm of 1m when the drawings indicated a longer length (approximately 2.4m) should have been used.

Figure 7.3: Approach by Mr Harding to design NWC diaphragm connection (Source: ARCE Structural Calculations 1986)

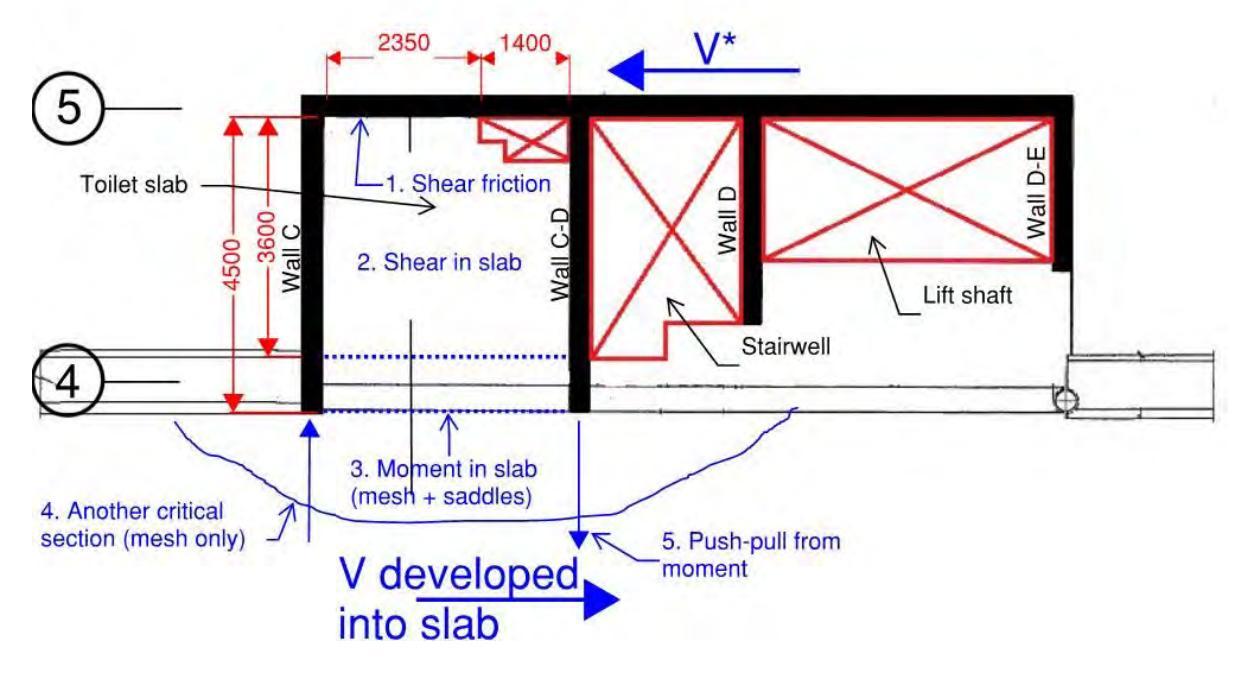
Figure 10.1 shows all the critical areas that should have been checked by a structural engineer when checking the ability of the connection to transfer a shear force, V*, from grid 5 to grid 4, and adequately develop it into the floor slabs south of grid 4.

- 1. Included the contribution of two layers of 664 floor mesh in the calculation of the shear-friction capacity of the toilet slab to grid 5 wall connection, even though the drawings indicate the mesh is not sufficiently anchored into the wall to justify its full inclusion.
- 3. Failed to check the moment action effect generated by the 4.5m lever arm between grids 5 and 4 (critical areas 3 and 5 in Figure 10.1).
- 4. Failed to check a critical section beyond the grid 4 starters towards the middle of the floor slab (critical area 4 in Figure 10.1).

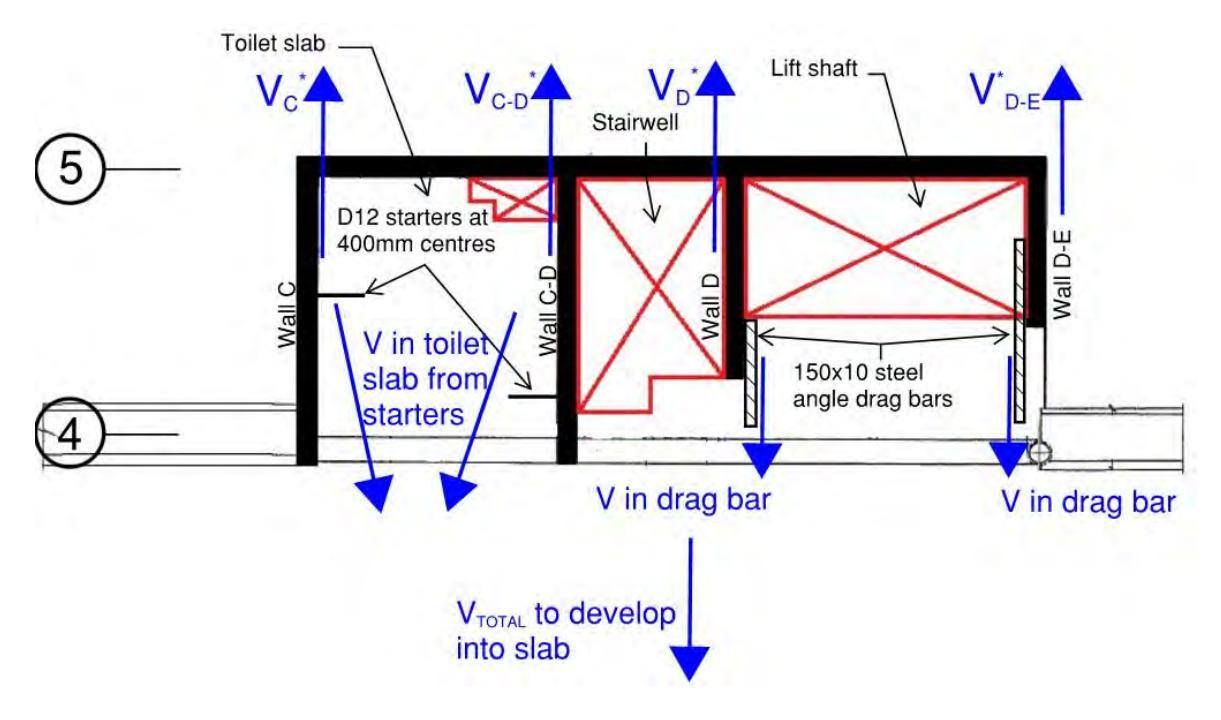
Notwithstanding Mr Banks' use of connection force values in the north-south direction that were of the order of what was expected for the time, we have identified that Mr Banks failed to check the development of tension forces in the drag bars into the floor slabs (Figure 10.2). The drag bars only extend a short distance beyond the end of walls D and D-E and create a critical section beyond their termination point that wasn't checked.

Due to this omission, the retrofit design by Mr Banks was flawed and the drag bars unlikely to be capable of fully developing the loads for which they were intended.

Figure 10.2: Diaphragm connection to North Wall Complex for north-south loading

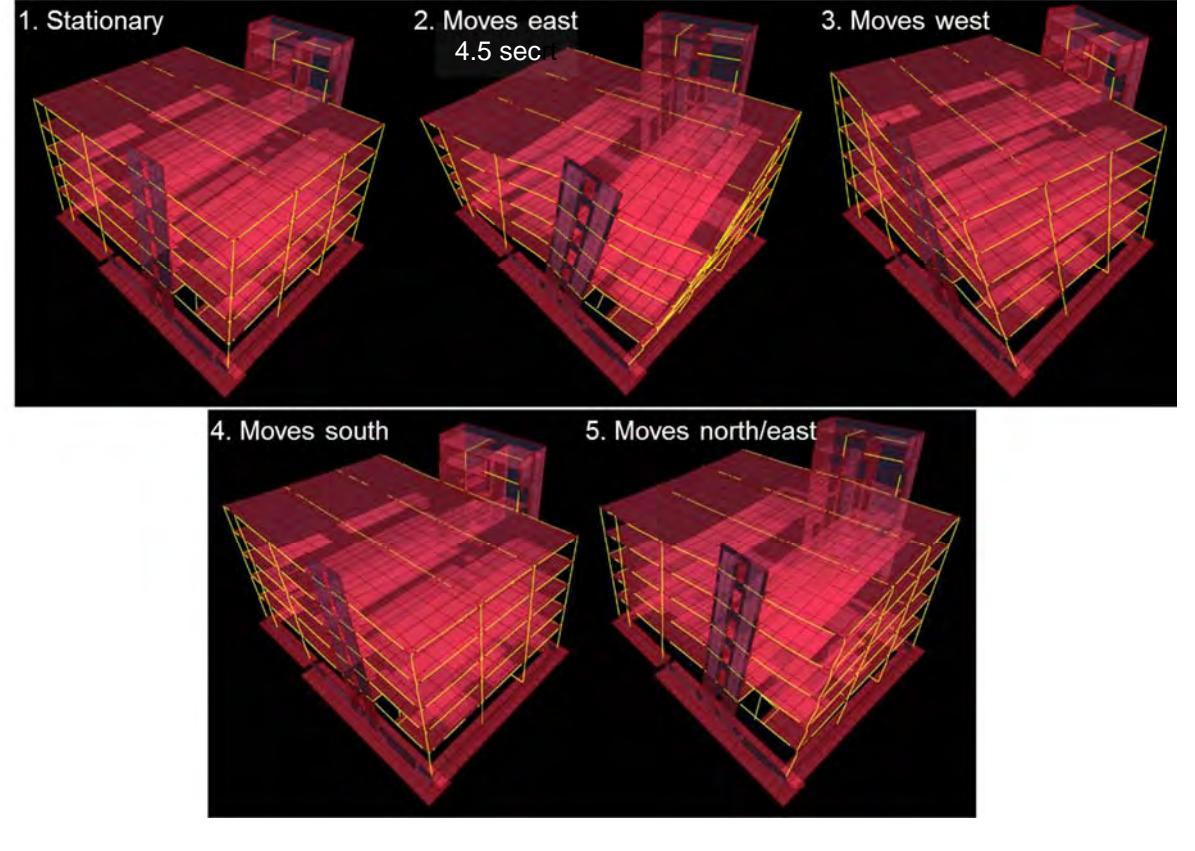
The sequence of significant movements the building experienced during the NLTHA for the as-designed model using the CCCC record is shown in Figure 12.1. Note: the horizontal building movements have been exaggerated for viewing purposes and are not representative of the scale experienced by the actual building during the 22 February 2011 earthquake.

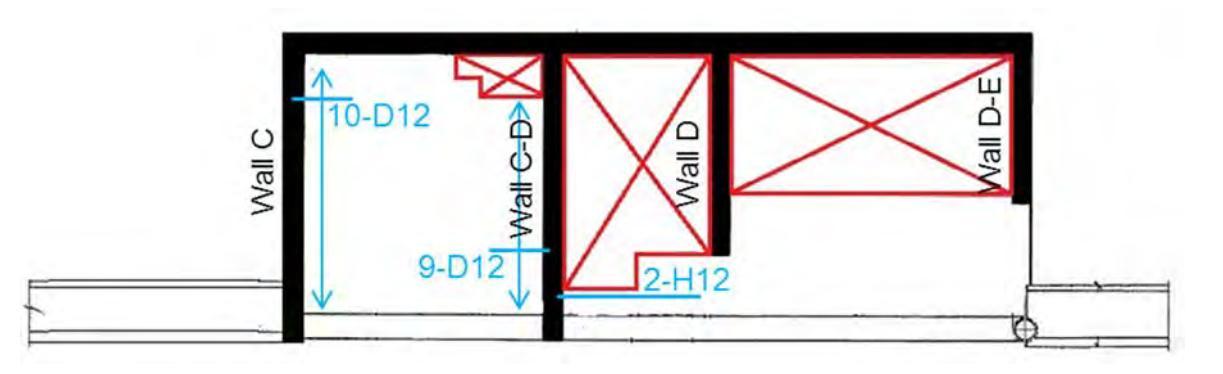
Figure F4: Details of diaphragm connection to North Wall Complex

The only significant connection between the floor slabs and the North Wall Complex was to walls C and C-D through starter bars between the slabs and the walls (Figure F4).

Assuming the best case scenario where the shear capacity provided by these connections can fully develop into the floor slabs, the capacity of the connection assessed using shear friction principles from 7.3.11 of NZS 3101:1982 is as follows:

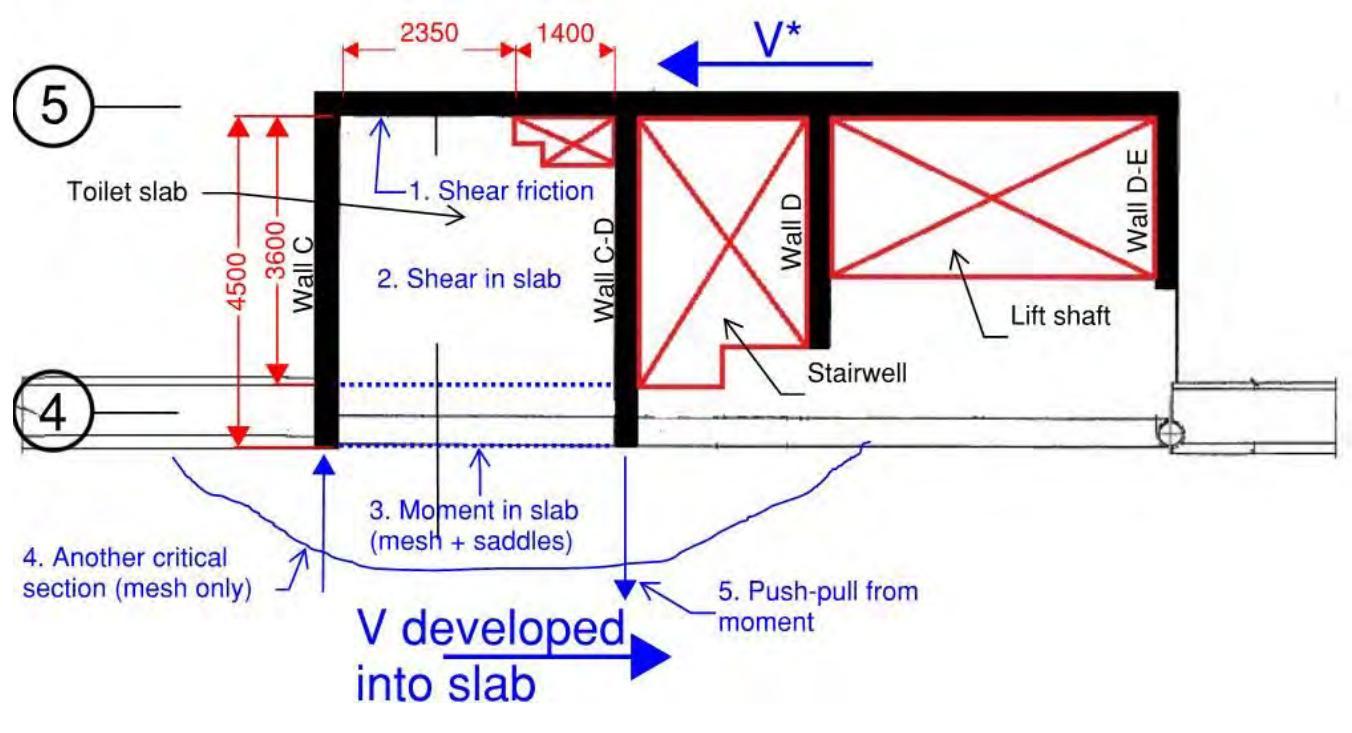
Figure F5: Diaphragm connection to North Wall Complex for east-west loading

- 1. Shear friction at interface between toilet slab and grid 5 wall
- 2. Shear in the toilet slab itself
- 3. Moment in the toilet slab near grid 4
- 4. Shear in the floor slab outside grid 4
- 5. Development of the moment generated by the lever arm between grids 4 and 5 into the floor slab.

We calculated the capacity of the first three and compared against the demands from Table F7.

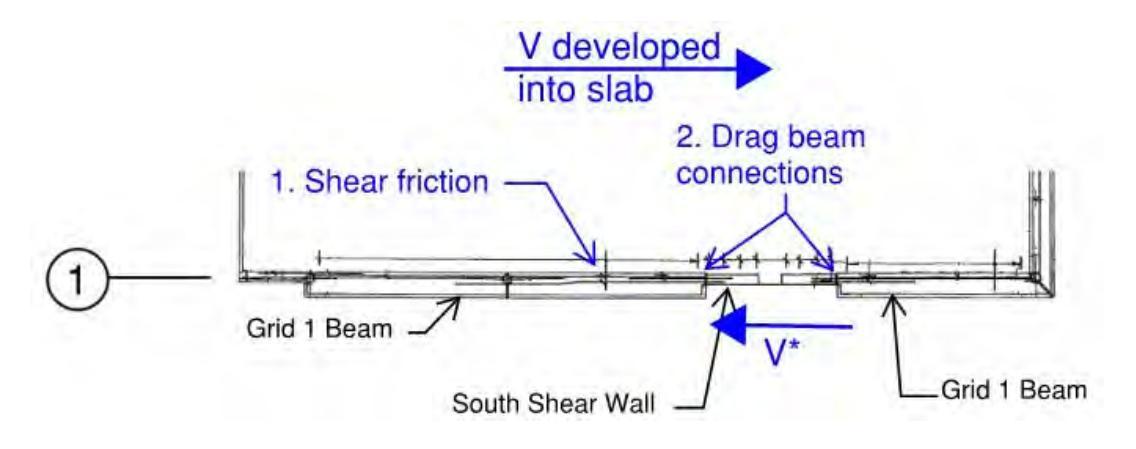
Figure F6: Diaphragm connection to South Shear Wall for east-west loading

The diaphragm connection to the South Shear Wall for loads in the east-west direction relies on the 5m length of direct connection and the grid 1 beams either side acting as drag beams. In order to sufficiently develop diaphragm forces between the South Shear Wall and the floor slabs, the following aspects, at least, must have adequate capacity (Figure F6):

- 1. Shear friction at the grid 1 interface
- 2. Drag beam connections

We calculated the capacity of these aspects and compared against the demands from Table F7.

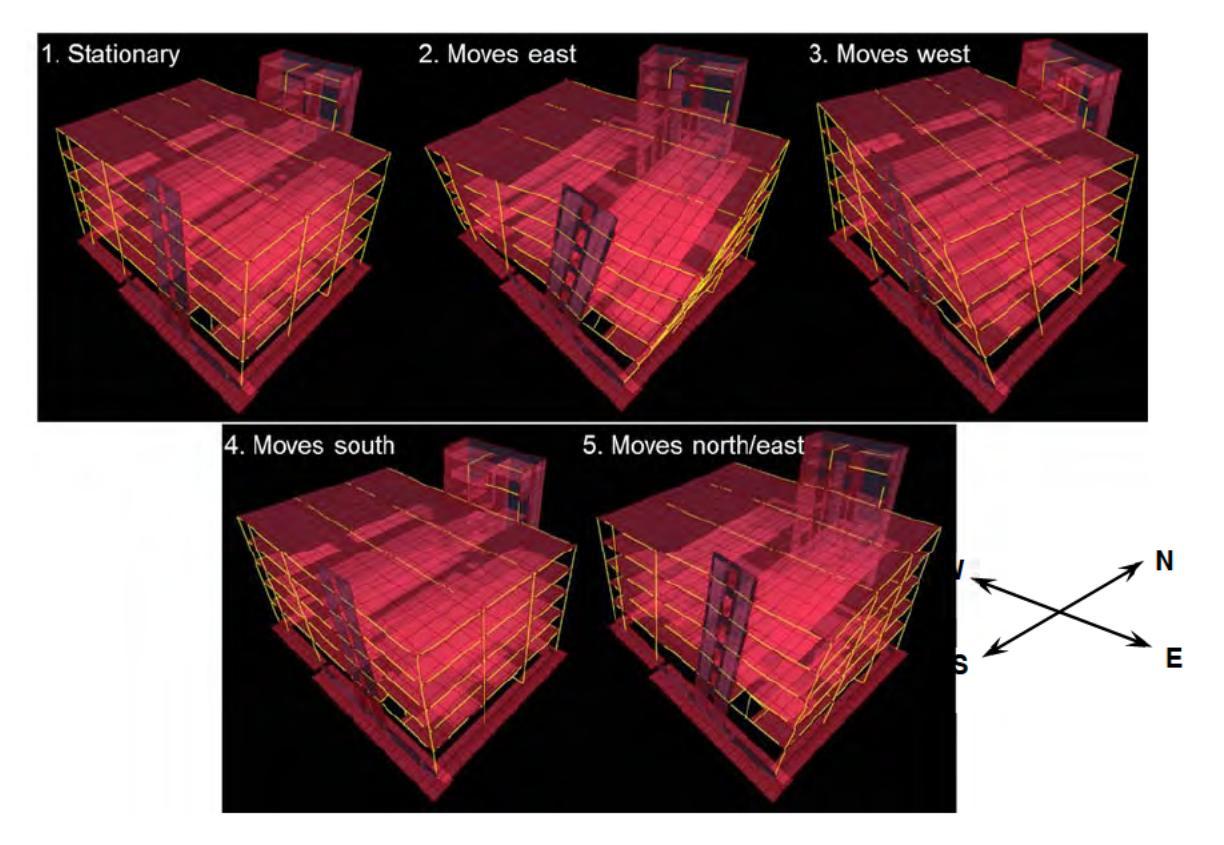
Figure H2: Building movement sequence from the NLTHA using the CCCC record for the 22 February 2011 earthquake (Source: Note the deformations are shown to an exaggerated scale.

Approximately 4.5 to 5 seconds into the earthquake analysis (step 2 in Figure H2 and as shown on Figure H3), the building moved significantly to the east, pivoting about the NWC. This resulted in very high inter-storey drift demands along the southern elevations (Grid Lines 1 and 2), with maximum inter-storey drifts in the order of 2.5 to 3.5% drift. This movement was sufficient to cause significant yield at the base and

in the coupling beams of the SSW and in the column regions just below the soffit of the internal beam on Grid 2 at Level 2 (L2).

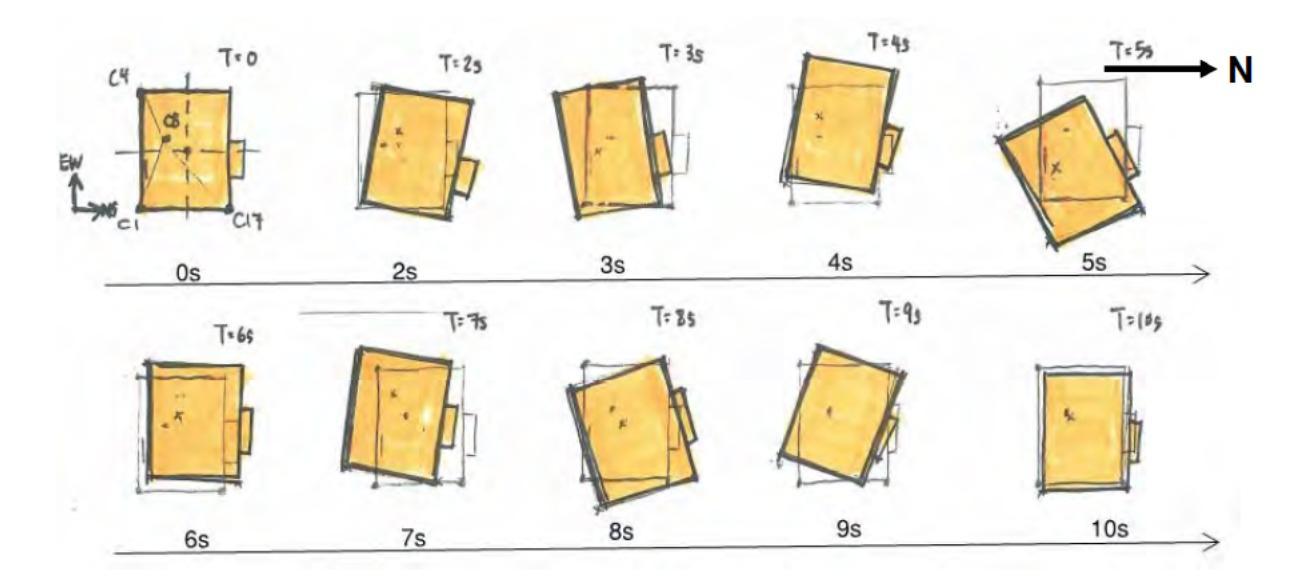
Figure H3: Building movement sequence from the NLTHA using the CCCC record for the 22 February 2011 earthquake. Note the deformations are shown to an exaggerated scale.

Beyond 5 sec (Figure H3), the building swayed towards north-west and then south-east for a few cycles, with predominant movement in the east-west direction.

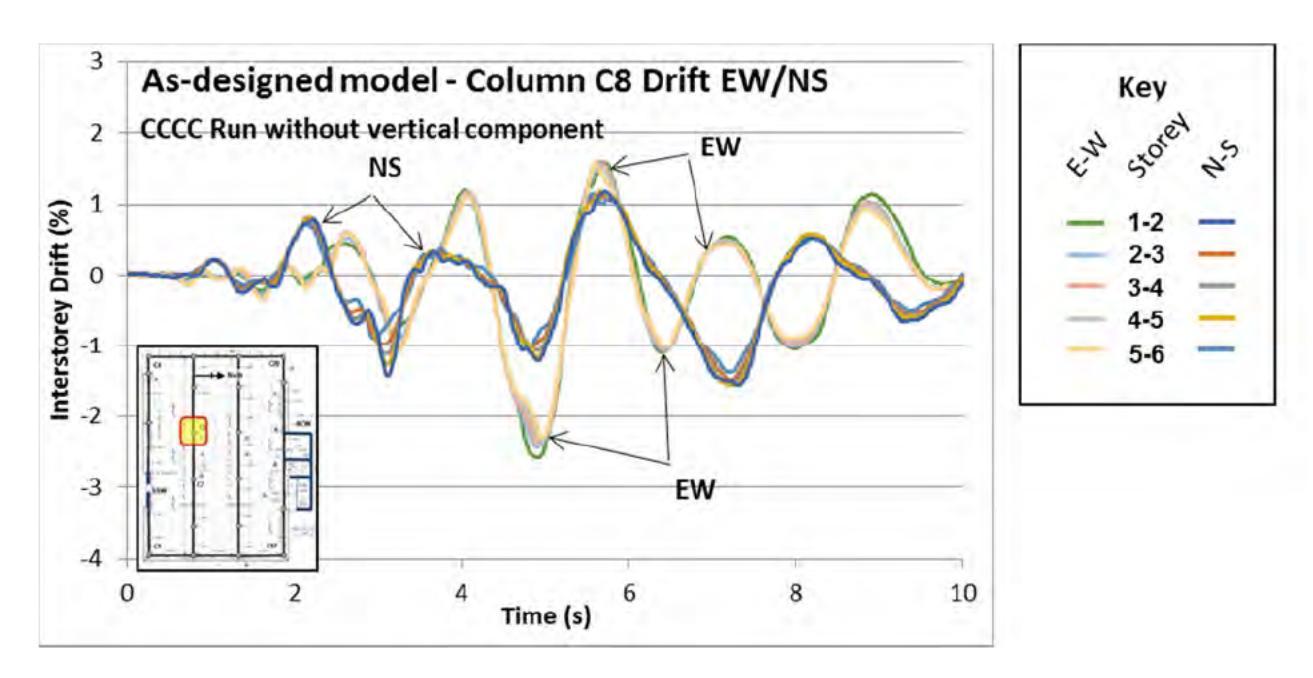
Figure H4: Inter-storey drift response of Column C8 for As-designed model for CCCC 22 February 2011 record without vertical acceleration component. Positive drift/displacement is movement to the west and north respectively.

Table H1 presents the drift response for Column C8 for both our compliant and as-designed models. Column C8 is considered to be a critical column due to the high gravity load taken by it. The horizontal interstorey drift demands for Column C8 observed for the as-designed model exceeded 2% to 2.5% in the eastwest direction and 1.5% in the north-south direction.

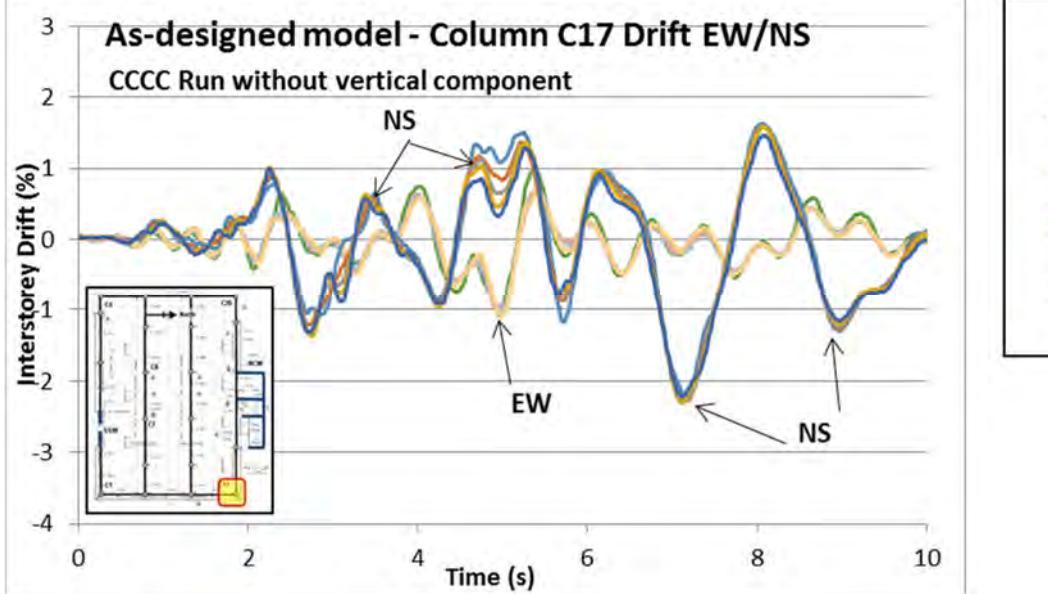
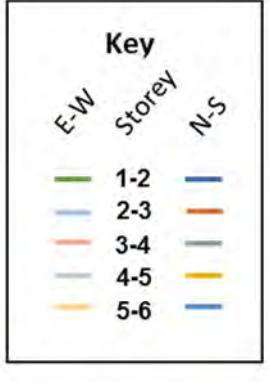
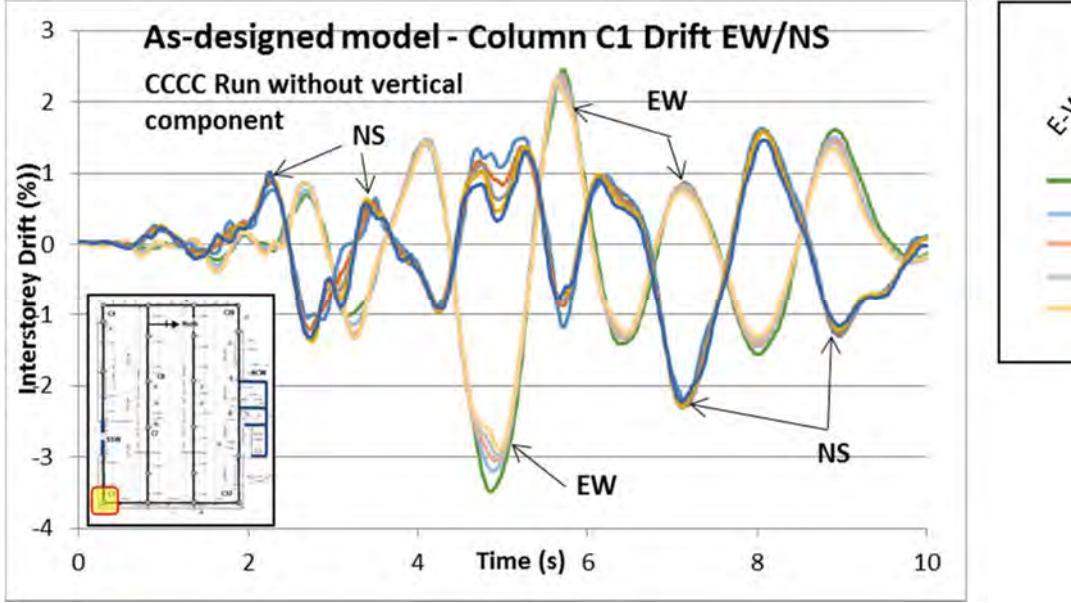
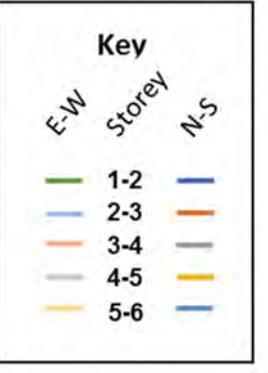
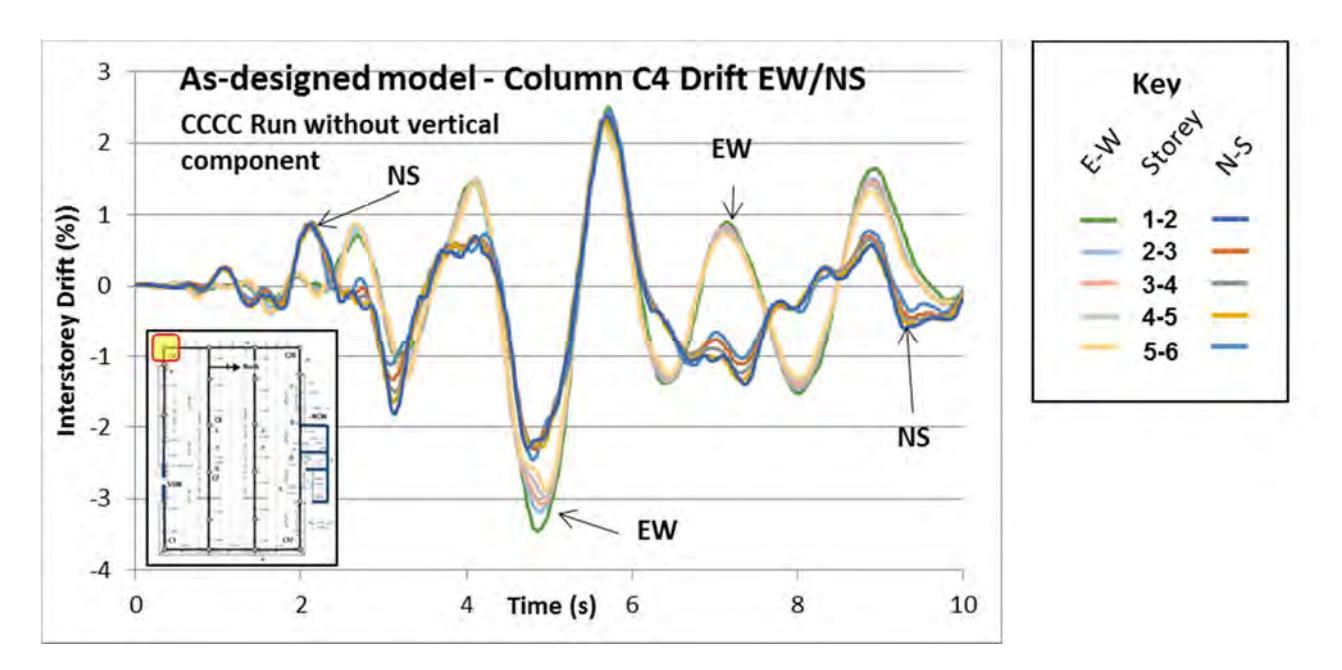
Figures H5, H6 and H7 show the time-history plots of the inter-storey drift response at Column C17 (northeast corner), column C1 (south-east corner) and column C4 (south-west corner) respectively.

These plots indicate that the inter-storey drifts were generally reasonably consistent over the height of the building and were a maximum on the south perimeter.

Figure H5: Inter-storey drift response of Column C17 for As-designed model for CCCC 22 February 2011 record without vertical acceleration component. Positive drift/displacement is movement to the west and north respectively.

Figure H6: Inter-storey drift response of Column C1 for As-designed model for CCCC 22 February 2011 record without vertical acceleration component. Positive drift/displacement is movement to the west and north respectively.

Figure H7: Inter-storey drift response of Column C4 for As-designed model for CCCC 22 February 2011 record without vertical acceleration component. Positive drift/displacement is movement to the west and north respectively.

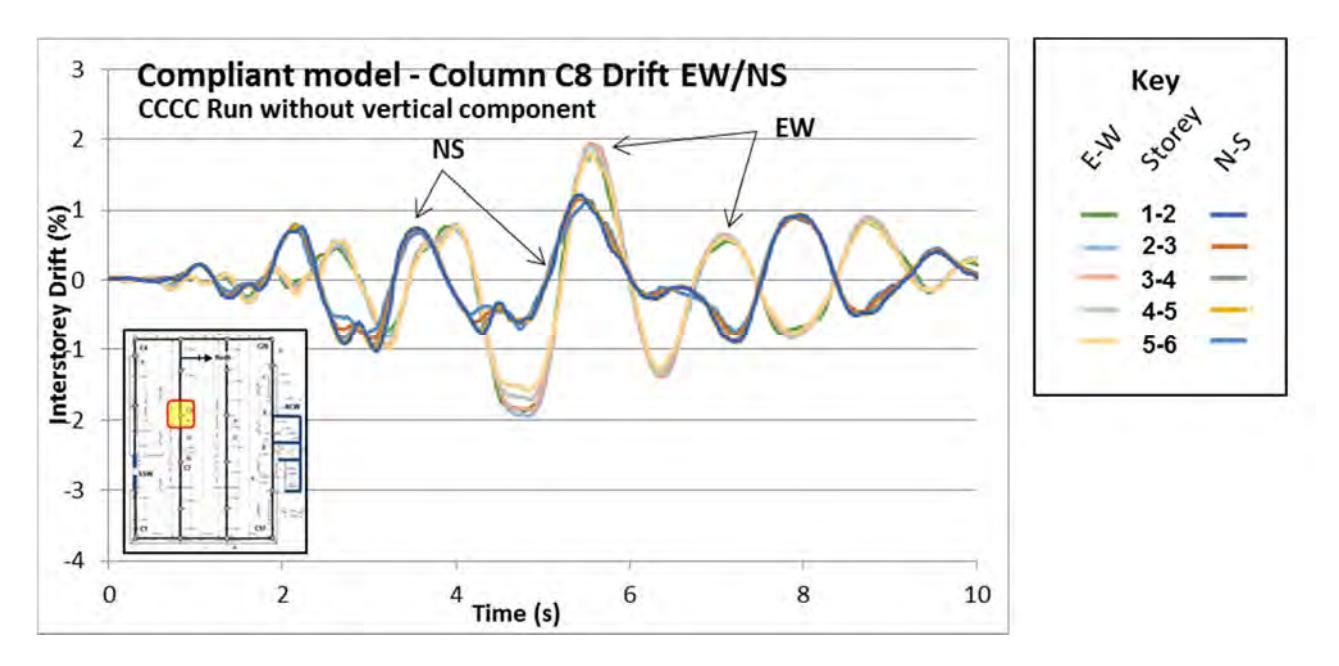
Figure H8: Inter-storey drift response of Column C8 for Compliant model for CCCC 22 February 2011 record without vertical acceleration component. Positive drift/displacement is movement towards the west and north respectively.

The stronger NWC and SSW for this model mean the lateral displacement responses were lower than for the as-designed model. The horizontal inter-storey drift demands observed in the compliant model are approximately 1.9-2.0% in the east-west direction and 1.2% in the north-south direction.

The reduction in the inter-storey drift demands between the as-designed and compliant model means the columns and beam-columns within the gravity frames sustained a lower demand than for the as-designed model. Furthermore, as the beam-column joints are expected to remain elastic in the compliant model, the susceptibility of collapse due to the axial-load carrying capacity degradation of the beam-column joints is removed. This is a significant difference from the as-designed model.

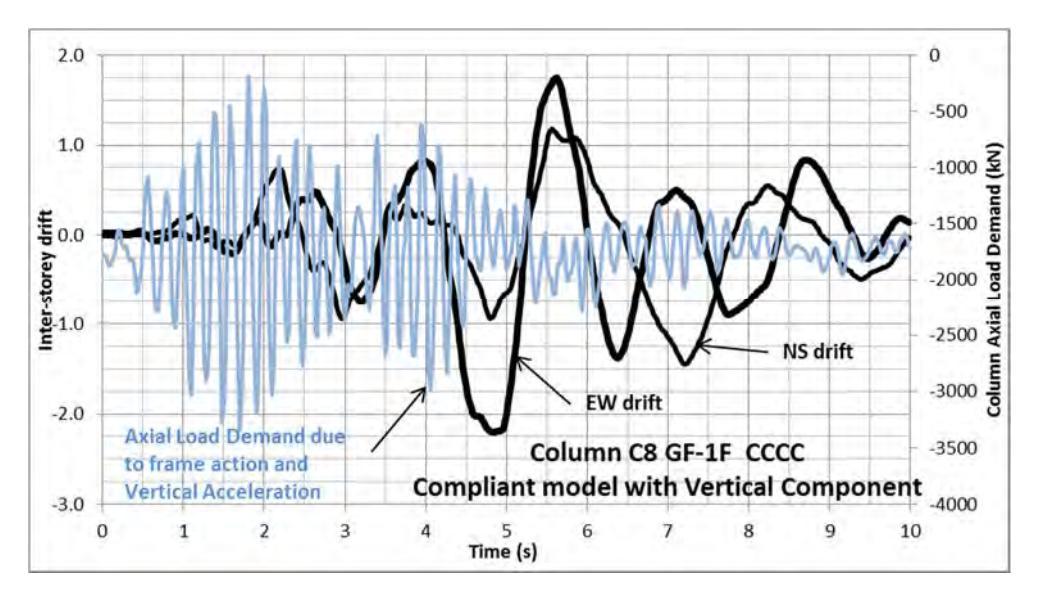
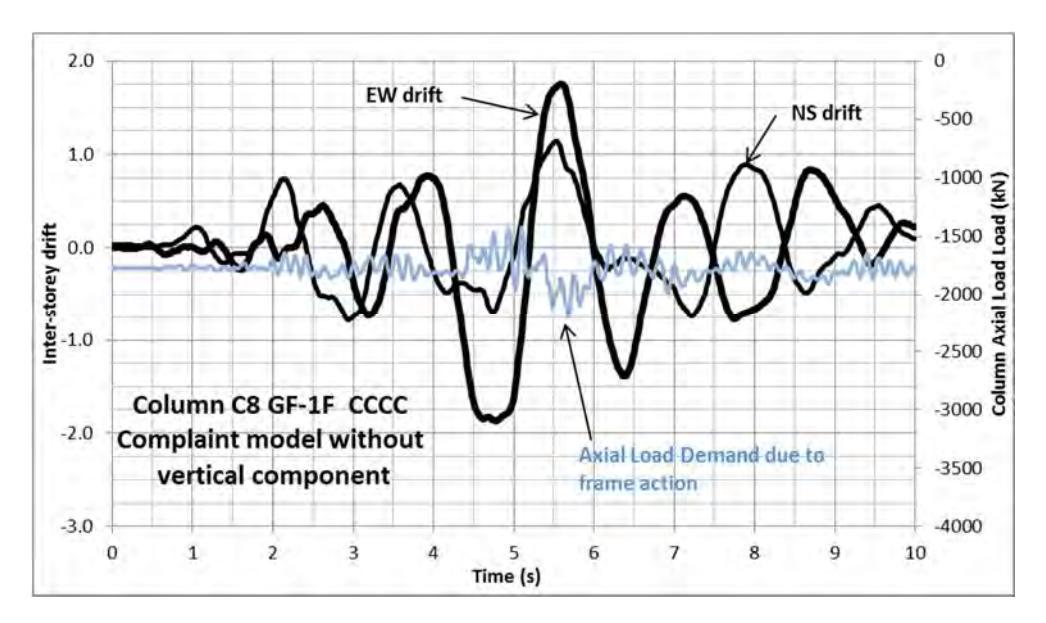
Figure H10: Time history response of Vertical Acceleration/Axial Load Demand and inter-storey drift for Column C8 for CCCC 22 February 2011 record

Axial load and the lateral inter-storey drifts for Column C8 for the compliant model are shown in Figure H10 for the CCCC record, with and without vertical acceleration. The difference in the column axial load response between the two plots is indicative of the axial load demand arising from the vertical acceleration component. It can be observed that the high frequency vertical acceleration demand generally occurred early in the record (<4s) and had significantly reduced by the time the building was subjected to the main horizontal pulses which resulted in the large swing to the east at approximately 4.5s.

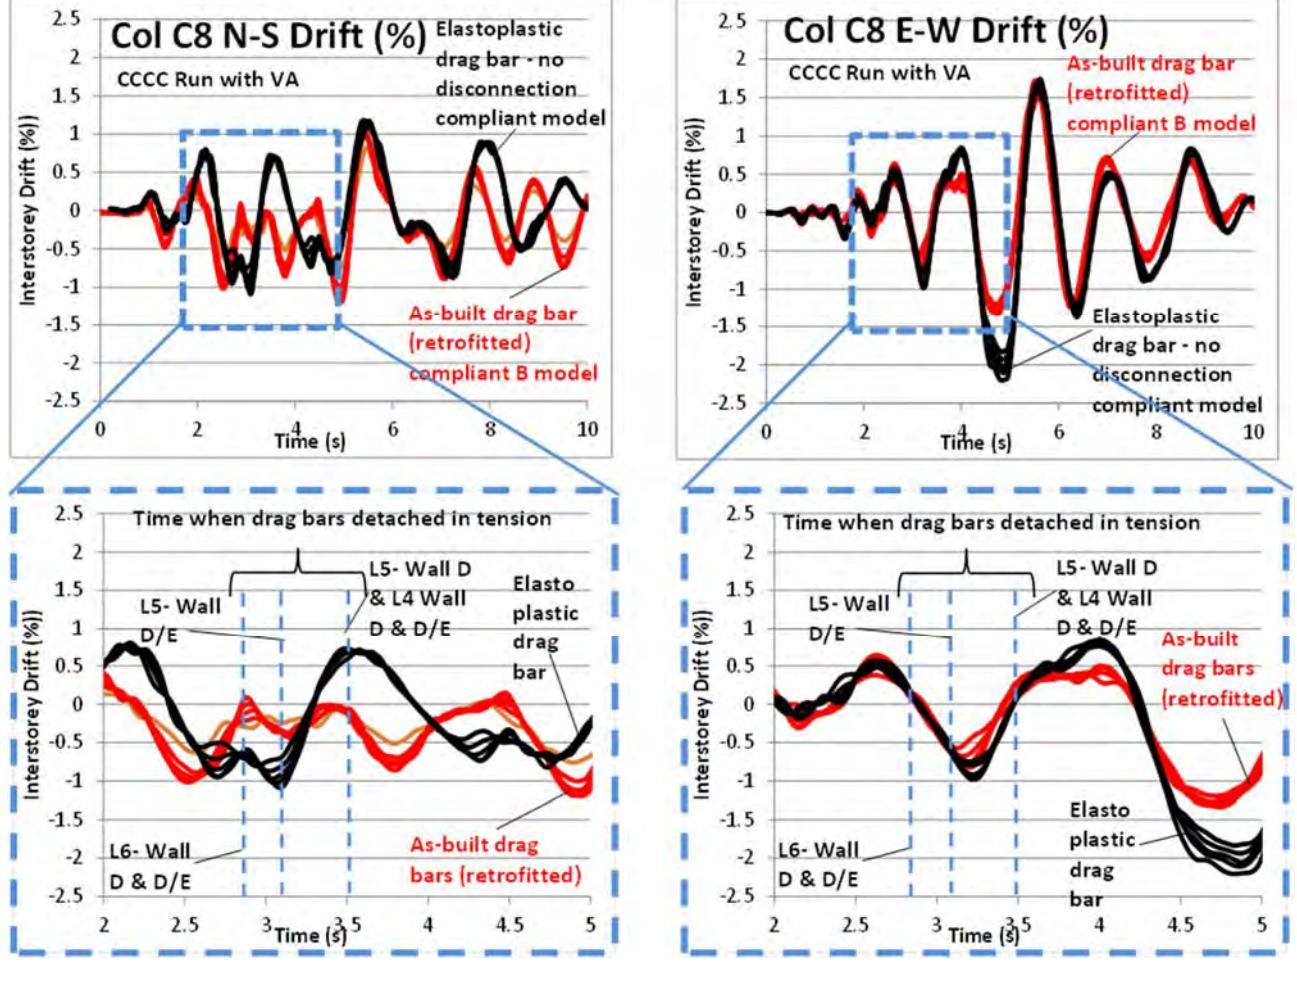
It can be observed from Figure H11 that the analysis results for the model with compliant drag bars (black line plot in Figure H11) has a higher inter-storey drift demand in the east-west direction at the critical column C8 than for the compliant B model.. The response in the north-south direction is also affected by the presence of the compliant drag bars.

Conversely in the compliant model B, the drag bars are effectively detached circa 3 to 3.5s into the analysis. The loss of the force-couple and axial connection to the slab reduces the effective lever arm of the NWC in the east-west direction. The torsion force couple is, therefore, limited to Grid Lines C and C/D. This reduces the east-west translational stiffness and torsional stiffness of the NWC. This significantly reduces the east-west translational stiffness which in turn reduces the plan irregularity and displacement demand along the southern elevations (Grid Lines 1 and 2) under the east-west direction shaking. The reduced torsional stiffness has less influence than the reduced plan eccentricity.

Notwithstanding these differences, the results indicate that for both the compliant and compliant B models the interstorey drifts are below those that would result in an axial failure in the columns. We therefore conclude that the deficiencies identified in the retrofitted drag bars as installed, on their own (i.e. in an otherwise compliant building), were not a substantial cause of the collapse.

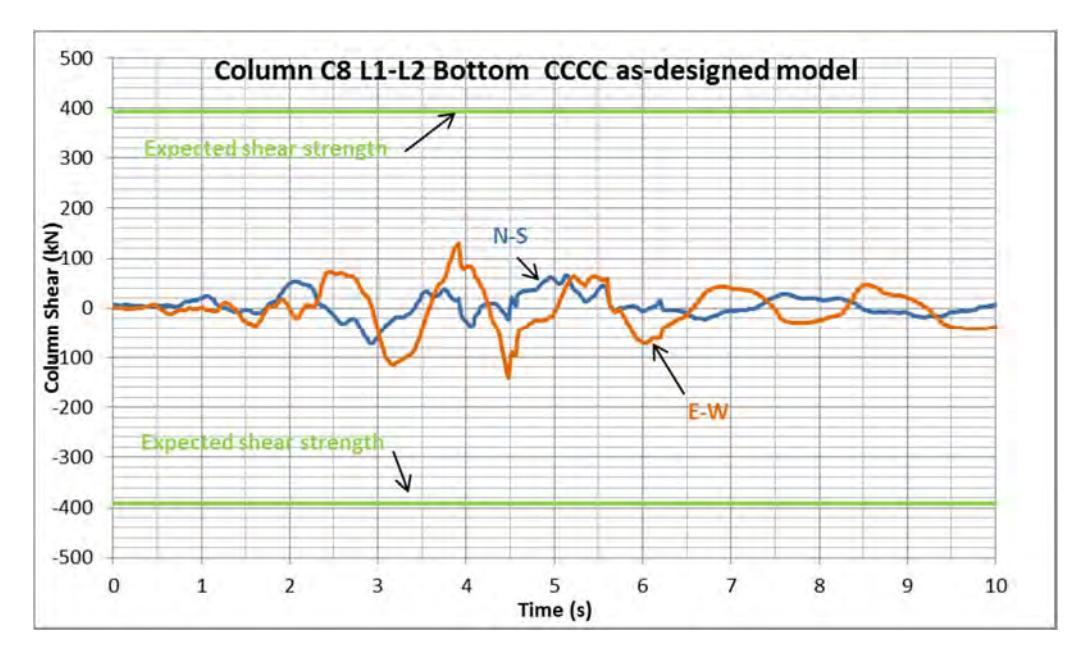
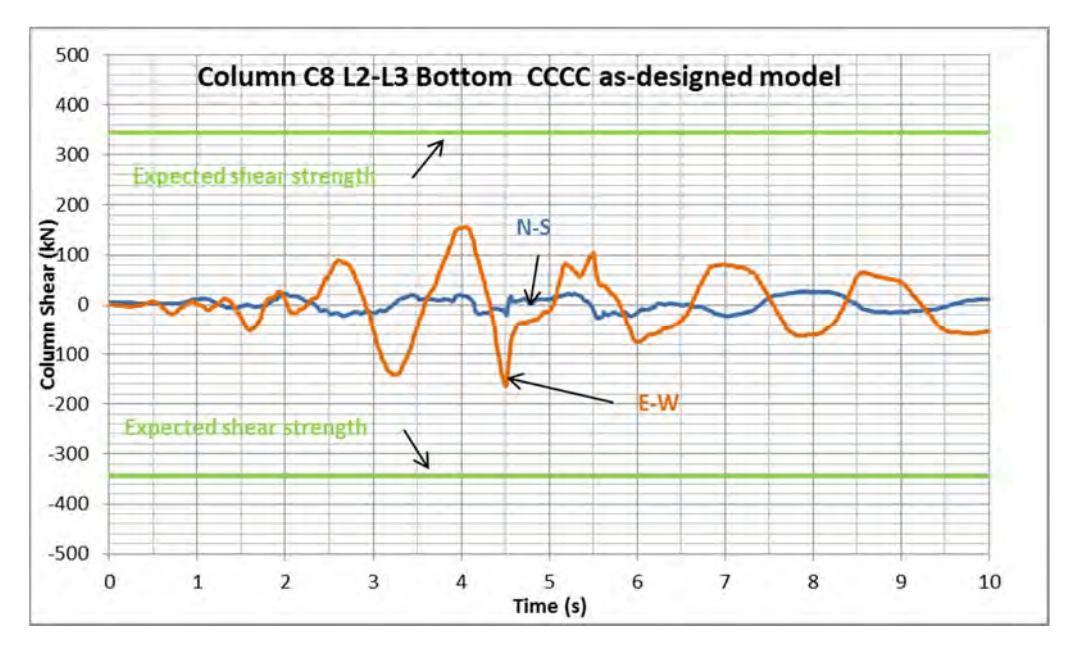
Figure H14: Column C8 end shear assessment for As-designed Model under CCCC 22 Feb 2011 shaking without vertical acceleration component

In general, the internal columns are expected to have flexurally-dominated behaviour with flexural hinging of the column ends expected to occur prior to shear cracking at the column mid-height. This is confirmed by the NLTHA results where flexural yielding at the top and/or bottom of the column generally limited the shear forces generated in the columns. Figure H14 shows the variation with time of the shear force actions in Column C8 under CCCC 22 February 2011 shaking without the vertical acceleration component. It is apparent that these shear forces are well within the shear strength of this column.
