CTV Investigation

Engineering Opinion Report

CTV Building Collapse - Engineering Opinion Report

Prepared for New Zealand Police

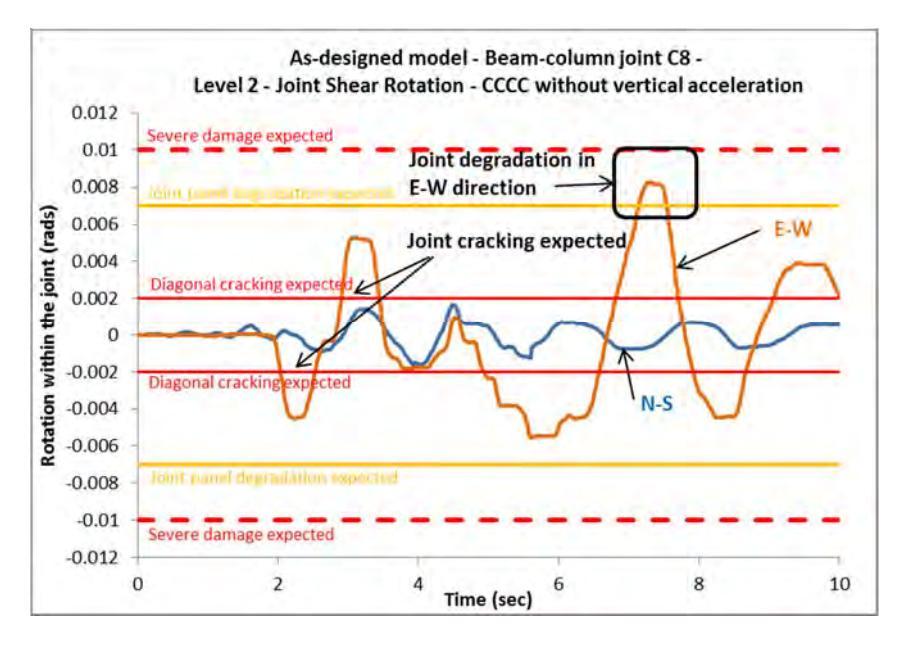
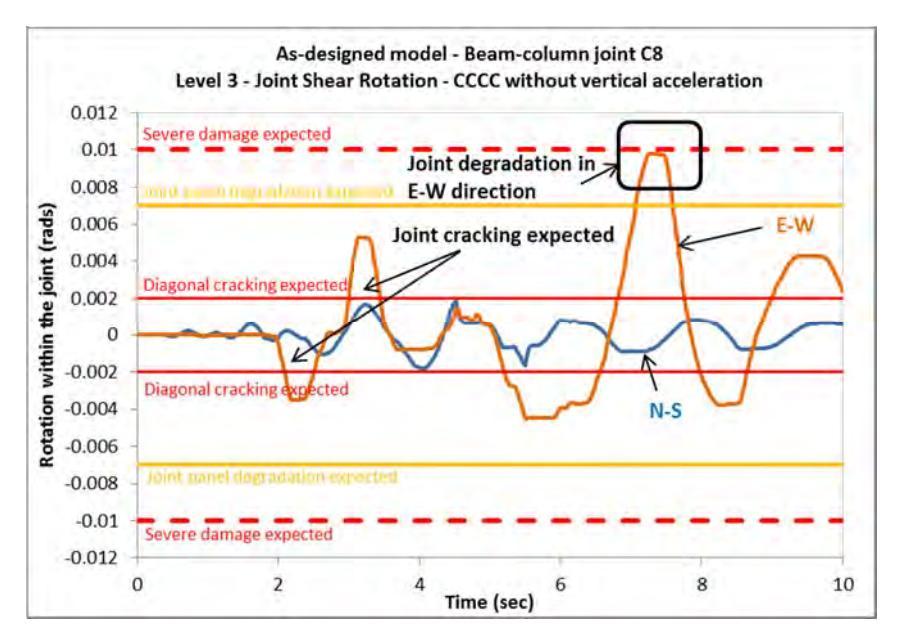
Figure H15: Joint shear rotation capacity assessment for As-designed Model under CCCC 22 February 2011 shaking without vertical acceleration component

Figure H15 presents an assessment of the damage expected in the beam-column joints at Column C8 for the as-designed model. The joint shear rotation response from our NLTHA is compared against the various available empirical joint shear deformation performance levels.

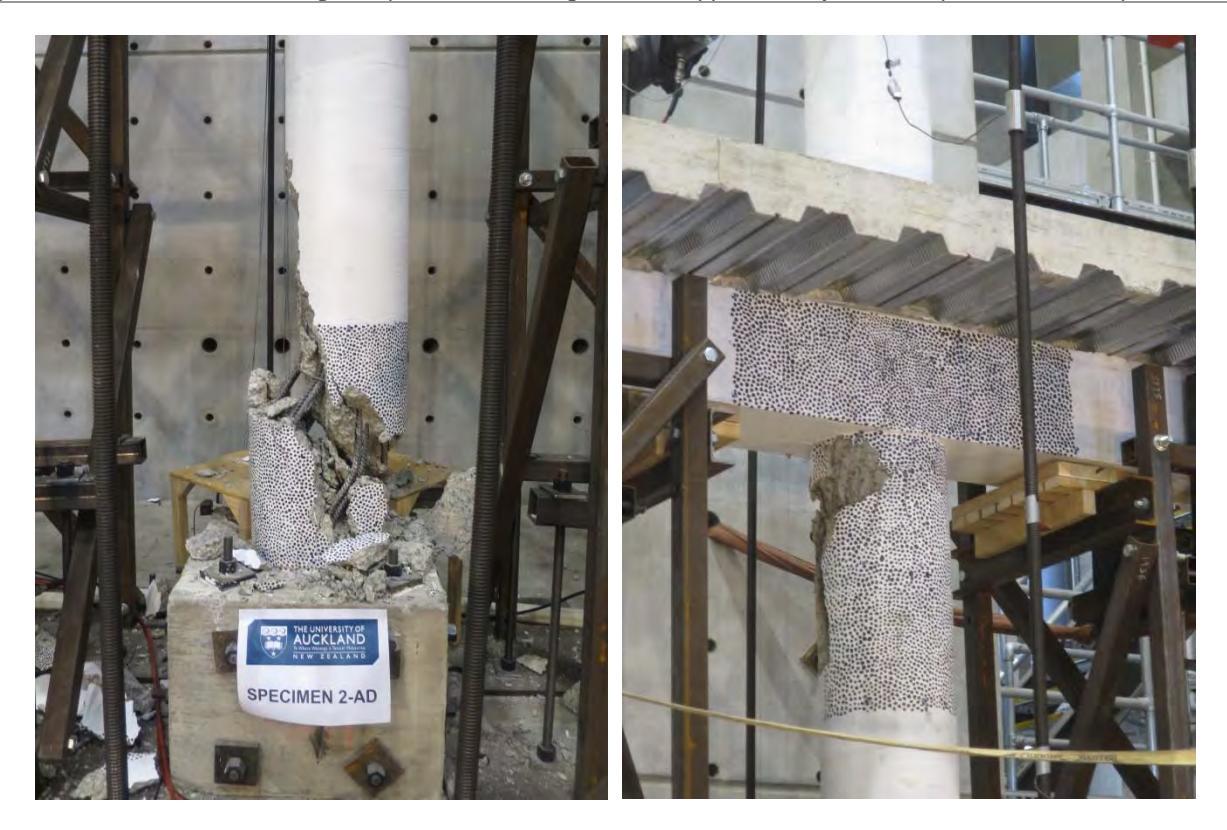
At the point of loss of axial load carrying capacity, the damage was most pronounced towards the bottom of the lower column, just above ground level (Figure K11). The damage in this location can be characterised as consisting of a steep diagonal failure plane (Figure K12a) with significant vertical and lateral displacement. The vertical drop along this failure plane led to the specimen's beams coming to rest on the 'catch-frames', which prevented any further downwards movement. There was some spalling of cover concrete at the top of the lower column just below the beam soffit (Figure K12b). There was also damage to the visible exterior of the beam-column joint region (Figure K13). It should be noted that the visible exterior of the joint zone shows any cracks manifesting in the unreinforced 'wings' of the ends of the precast beams – these cracks do not necessarily match what has manifested in the more-important in-situ core of the joint.

a) Bottom of lower column

b) Top of lower column

Figure K12: Damage to As-designed specimen following failure at approximately 95mm in-plane Level 2 displacement

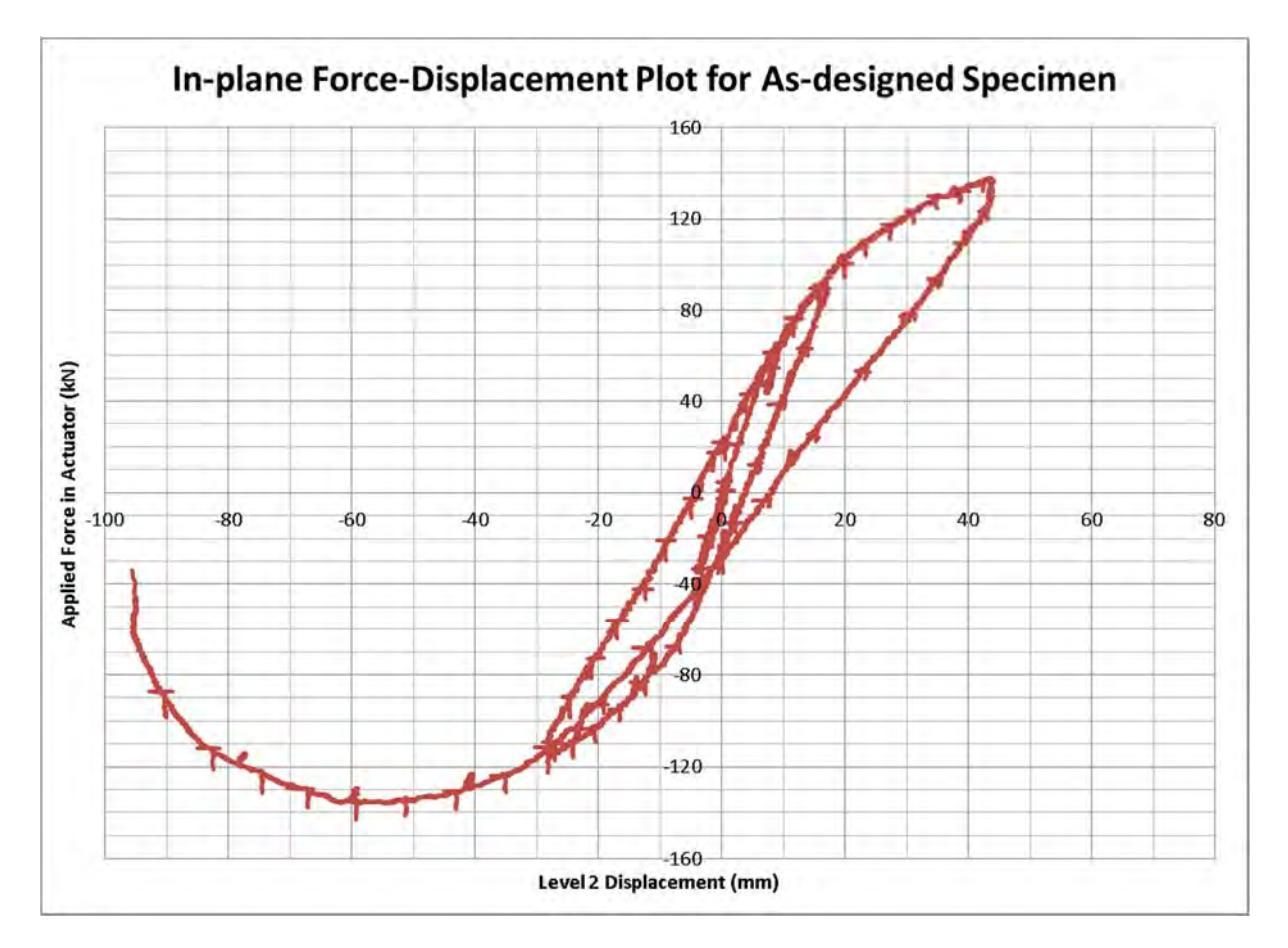
Figure K14: Force-displacement plot for As-designed specimen

The plot shows the excursions out to the displacement peaks corresponding to the cycles before failure. The specimen degraded in lateral stiffness from about 15mm displacement from vertical, with peak applied lateral force (140kN) occurring at a displacement of approximately 60mm. Applied lateral force began to reduce as lateral displacement increased beyond 60mm, at an ever increasing rate. At approximately 95mm in-plane displacement, the specimen lost axial (and lateral) load carrying capacity.

A measured displacement of 95mm corresponds to an inter-storey drift of 2.6%, not including foundation rotation. The peak in-plane only displacement demand in step 1 was 95mm.

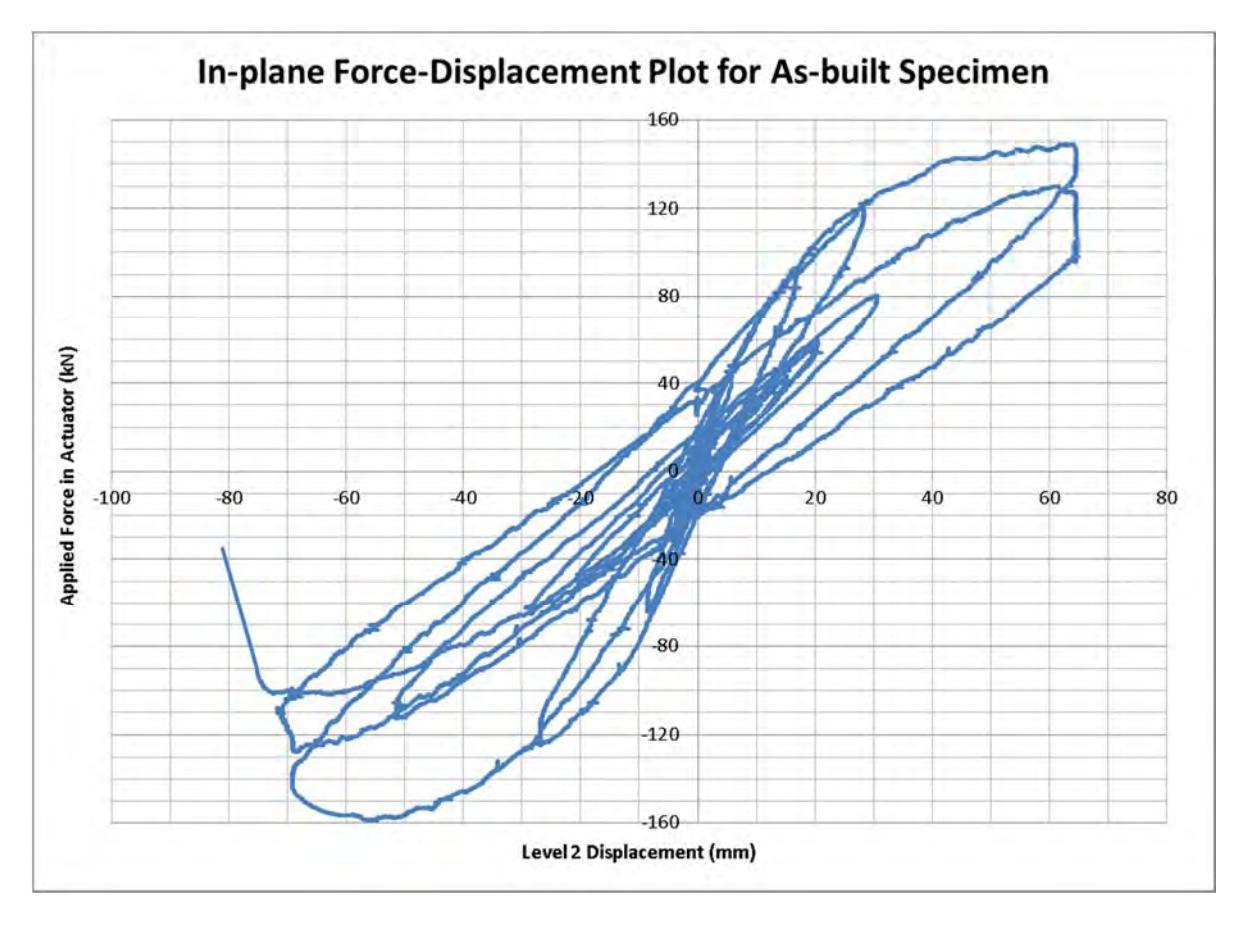
Figure K19: Force-displacement plot for 'Compliant design/construction errors' specimen

The plot shows the excursions out to the displacement peaks corresponding to the cycles before failure. The 'Compliant design/construction errors' specimen exhibited similar hysteretic behaviour to the As-designed specimen with increasing rate of softening of the specimen up to the peak applied lateral force (150-160kN) occurring at a displacement of approximately 60mm. Also, with each significant cycle, the specimen became softer as observed by the progressive flattening of the pre-peak line.

A measured displacement of 75mm corresponds to an inter-storey drift of 2.2%, not including foundation rotation.

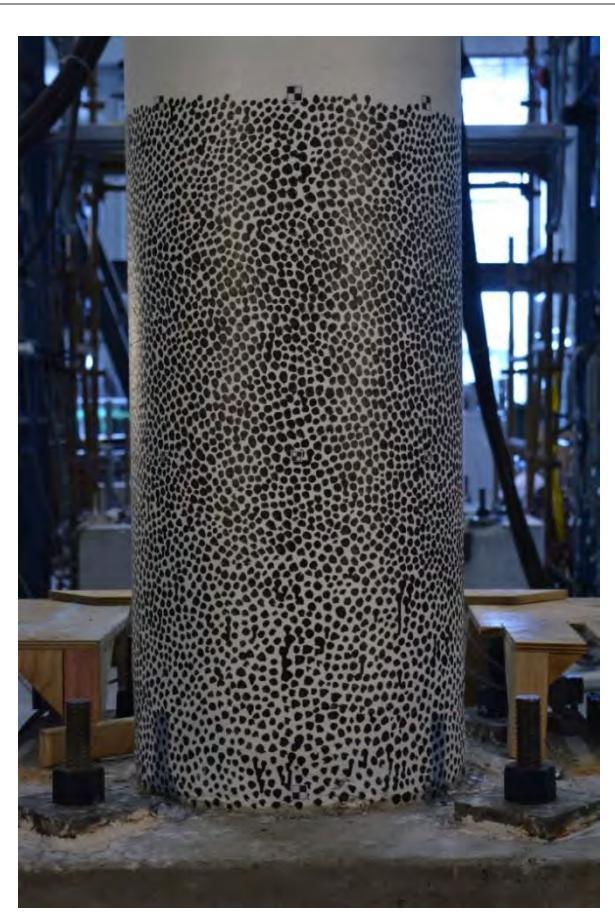
Nevertheless, with reference to Figure K10, we present below photos of the 'Compliant design/construction errors' specimen at the end of cycle 4, having been through an excursion to approximately 20mm in one direction, and 30mm in the other (more severe than was likely to have been experienced in the September 2010 earthquake) under the 'Compliant Model' regime. Figure K20 shows the top of lower column and joint region, and Figure K21 the bottom of lower column region (note, the dots in Figure K21 are paint marks used in conjunction with high-definition photogrammetry to determine crack patterns). These photos show that there is no visible damage, which suggests this region of the building following the September 2010 earthquake was likely to have also shown no visible signs of damage.

Figure K21: 'Compliant design/construction errors' specimen bottom of lower column at the end of cycle 4 after a maximum inter-storey displacement of 30mm

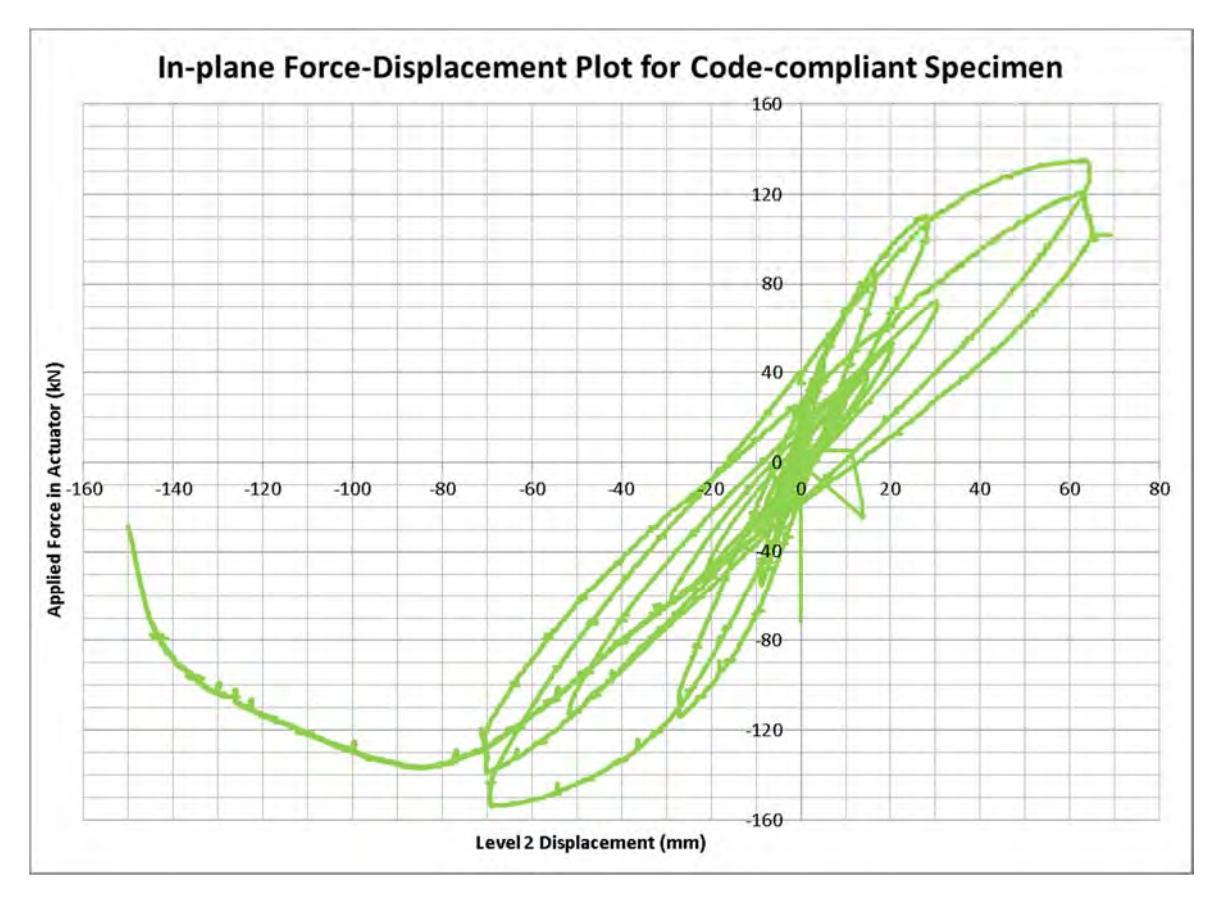
Figure K25: Force-displacement plot for Code-compliant specimen

A measured displacement of 150mm corresponds to an inter-storey drift of 4.2%, not including foundation rotation.

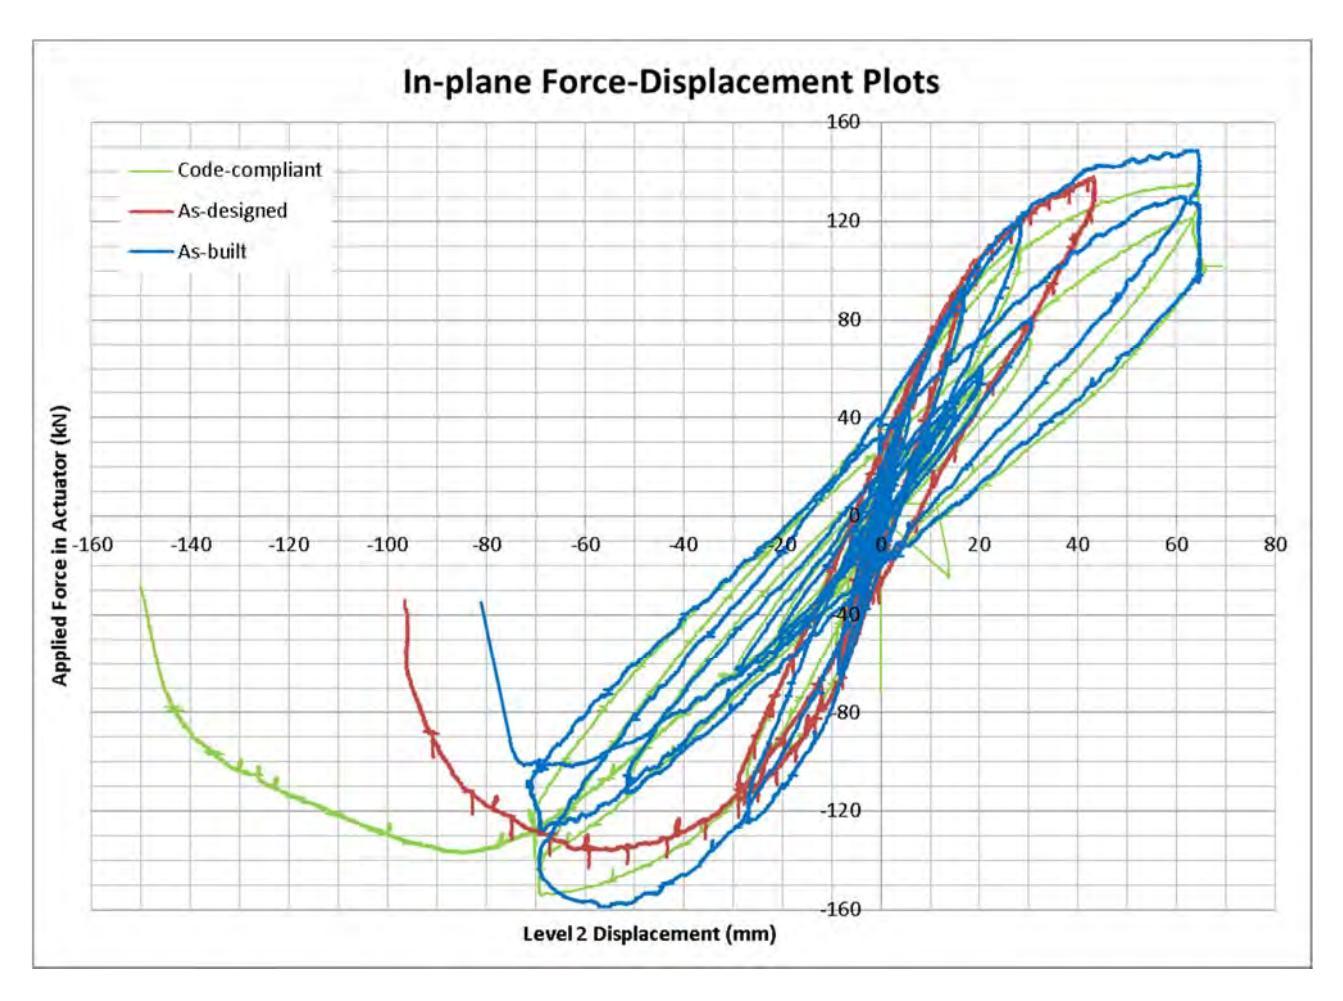
Figure K26: Comparison of force-displacement plots for the three specimens

Figure K26 presents the in-plane force-displacement plots from each of the three tests on the same plot for comparison. The figure shows that the hysteretic behaviour of all three specimens is comparable, with similar slopes in the early cycles and similar levels of softening in later cycles. The figure also illustrates the similar level of peak applied lateral force in both directions, and for all three specimens (varying between 135 to 160kN). In addition, the figure shows the relatively superior performance of the Code-compliant specimen in terms of displacement capability compared to the As-designed and 'Compliant design/construction errors' specimens.
